## Relation between changes in the modal properties and structural changes in an existing steel truss bridge

*Yasunao Matsumoto (Associate Professor, Vibration Engineering, Saitama University, Japan)*

**Abstract:** *This paper describes an investigation of the applicability of changes in modal properties of a bridge to structural health monitoring. Vibration measurements were conducted at an existing Warren truss bridge for road traffic in-service for more than 40 years. Experimental modal analysis applied to the measured data identified global vibration mode of a bridge span and local vibration modes dominated by vibrations of diagonal members. There were a partial fracture, cracks and pitting corrosions in diagonal members of the truss bridge detected during recent visual inspections and some of those damages were repaired during the investigation described in this paper. The effects of those structural changes on the modal properties identified were discussed with the results of finite element analysis so as to investigate the applicability of modal properties changes in global and local vibration modes to the identification of structural changes in truss bridges.*

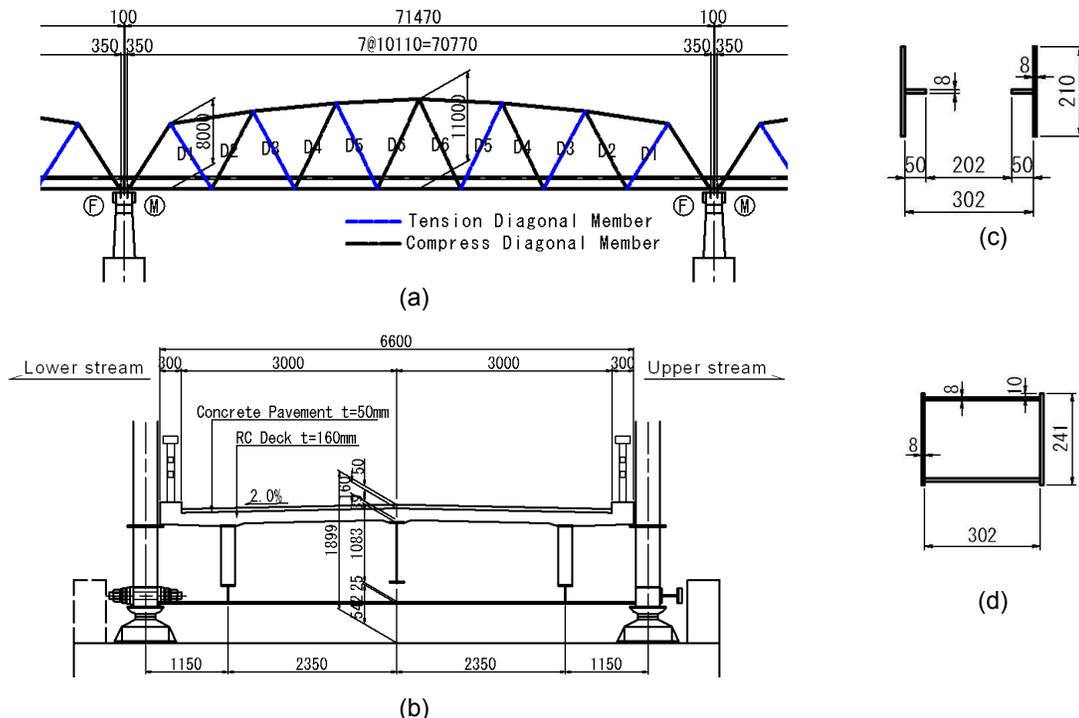
During a visual inspection in July 2007, a partial fracture was found near the bottom end of a longest tension diagonal member (D5 in Figure 1), which resulted in loss of the half of its cross section. There were cracks in four other longest tension diagonal members also. In August 2007, those damages were repaired by fixing additional steel plates with the same thickness as that of the member (i.e., 8 mm) by high strength bolts to cover both sides of the flanges and web for a length of about 1.5 m from the end of the member. Additionally, there were pitting corrosions in several shortest diagonal members (D1 in Figure 1) detected in the following inspections in 2009.

Figure 1 Steel truss bridge investigated: (a) side view of single span, (b) cross section of the bridge, (c) cross section of tension diagonal member, (d) cross section of compression diagonal member. Unit [mm].

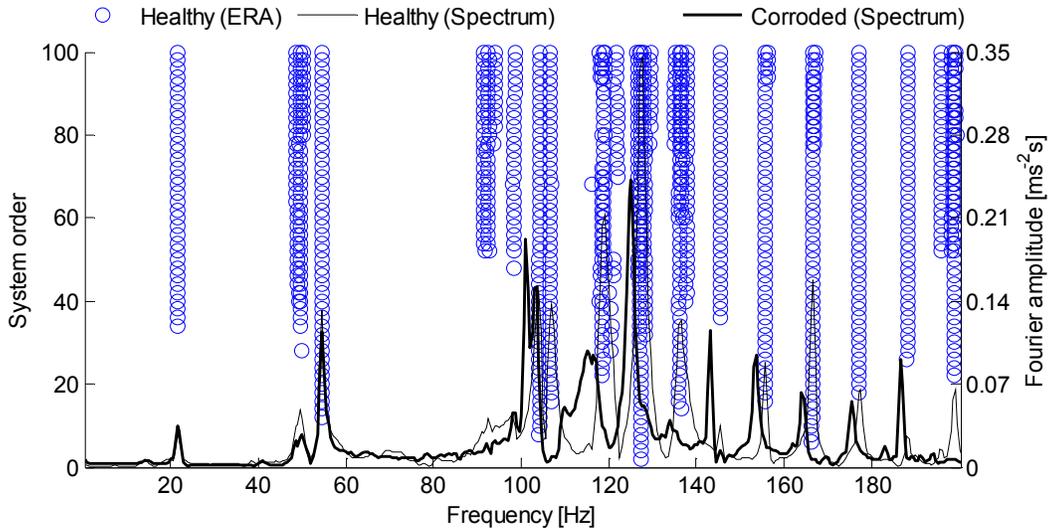
Figure 4 shows an example of the results of impact testing that compares the Fourier spectra of the response to impact of a diagonal member D1 with pitting corrosions (referred to as corroded in the figure) and that of a D1 without corrosion (referred to as healthy). In the figure, the stabilization diagram obtained from the Eigensystem Realization Algorithm, ERA (Juang & Pappa, 1985) for the diagonal member without corrosion is compared with the corresponding Fourier spectrum. The Modal Amplitude Coherence, MAC, was used to identify reliable natural frequencies in the ERA. The comparison between the Fourier spectrum and the stabilization diagram from the ERA implies that the natural frequency identified from the measurement records in the impact testing were reliable.

It was observed that the natural frequencies observed at frequencies above 100 Hz were different between healthy and corroded diagonal members, while there were minor differences in the frequency range below 100 Hz (Figure 4). The natural frequencies of the diagonal member with pitting corrosions appeared to be lower than those of the diagonal member without corrosions. Similar trend were found with the comparison between this diagonal member with pitting corrosions and other healthy diagonal members with nominally the same dimensions. The decreases in the natural frequencies in the frequency range above 100 Hz for the corroded diagonal member may be associated with decreases in the modal stiffness of higher order local vibration modes that are attributed to the pitting corrosions.

**Figure 4 Fourier spectra of response of healthy and corroded diagonal members to impact. Stabilization diagram from ERA obtained for health diagonal member are also shown.**

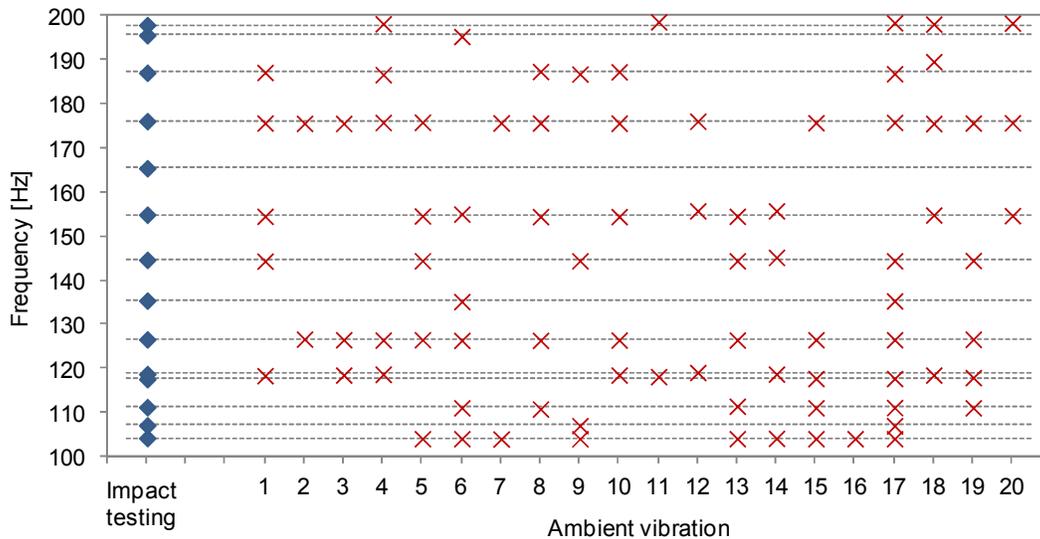
Figure 5 compares the natural frequencies of the healthy diagonal member identified by impact testing and those identified from twenty different records of ambient vibration in the frequency range between 100 and 200 Hz where the effect of the pitting corrosions was observed. In the analysis of the ambient vibration records, the ERA was applied to free vibrations observed after vehicle pass-bys. The natural frequencies identified from ambient vibration records were a subset of the natural frequencies identified by impact testing. However, what natural frequencies were observed varied depending on the ambient records used in the analysis as observed in Figure 5. In practical applications, a continuous ambient vibration measurement combined with some statistical analysis can be used to identify all natural frequencies within a frequency range of interest.

**Figure 5 Natural frequencies identified by impact testing and 20 ambient vibration records**

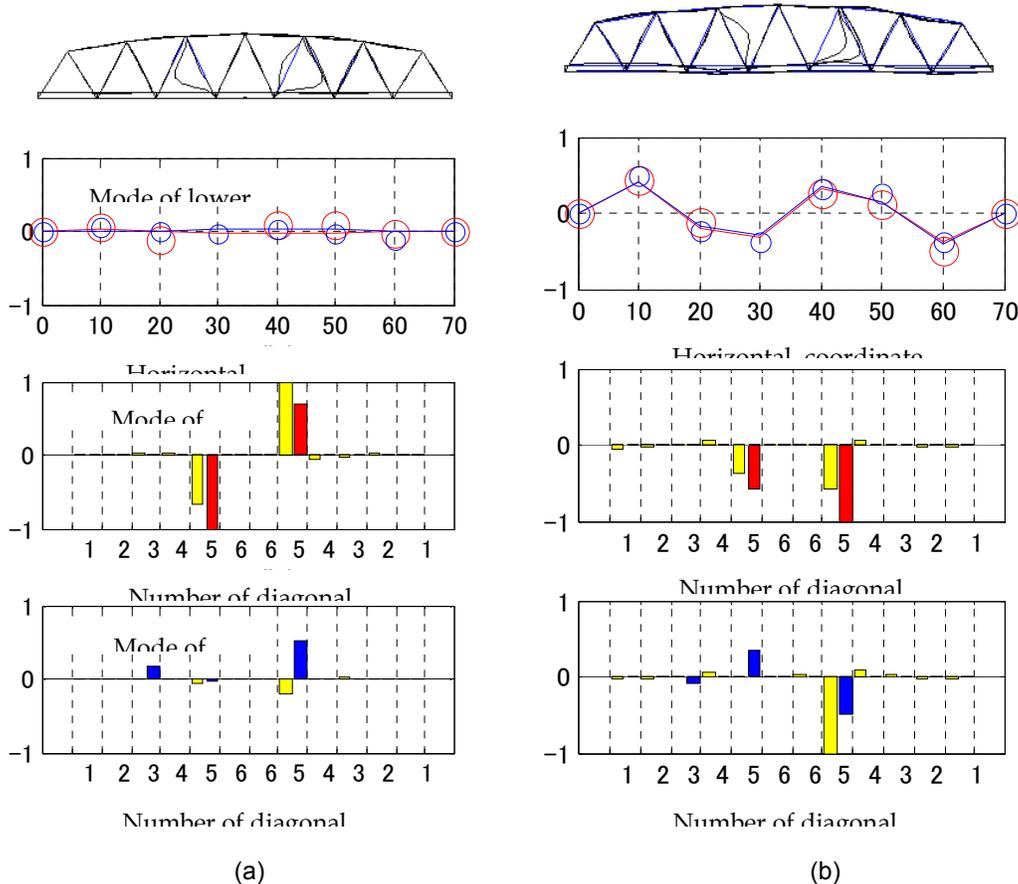
**Figure 6 Modal amplitudes corresponding to (a) local mode at 9.264 Hz and (b) coupled mode at 9.325 Hz. The vi-bration modes identified experimentally are compared with those obtained theoretically.**

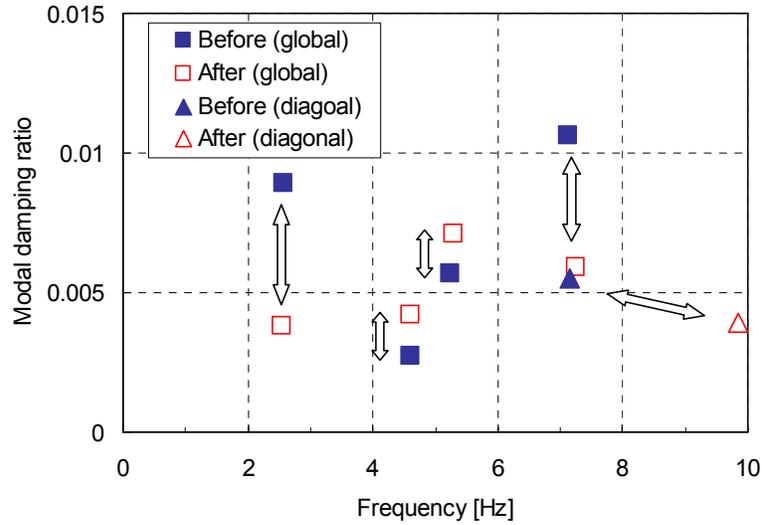
Figure 7 shows the changes in the modal frequencies and damping ratios before and after the

reinforcement of the diagonal members identified in Measurement 2. The modal properties shown in the figure were obtained by the ERA. The figure shows that, in the local vibration mode dominated by the motion of the diagonal member damaged and repaired, the modal frequency increased from 7.1 Hz to 9.8 Hz, approximately, and the modal damping ratio decreased from 0.0055 to 0.0039 after the reinforcement. In the global vibration modes involving the motion of the whole structure, there appeared to be changes in the modal damping ratio with minor changes in the modal frequency. It was noted that there was more variability in the identification of the modal damping ratio from the measurement records in the lowest order vibration modes, such as the mode at about 2.6 Hz in the figure, although the data are not presented in this paper. This variation in the damping was considered to be caused by the friction damping at the bearing supports that was dependent heavily on the displacement amplitude of vibration. In the global mode at about 7.3 Hz, however, there was less variability in the identification of modal damping ratio and the change in the modal damping shown in Figure 7 was more reliable than the changes in the lowest order vibration modes.

**Figure 7** Examples of changes in modal frequencies and damping ratios before and after reinforcement of diagonal members.

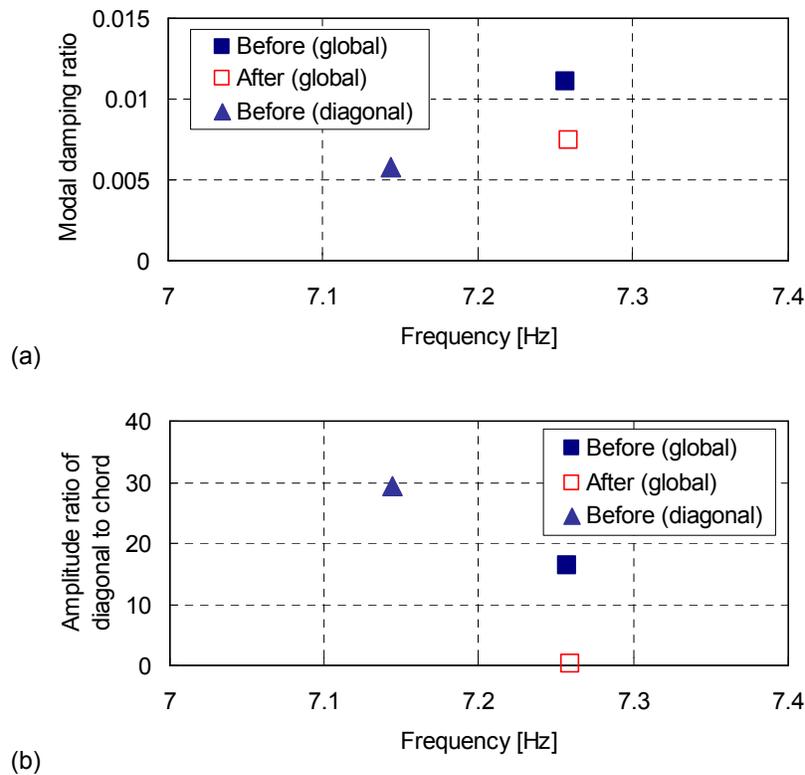
Figure 8 shows the relation between the changes in modal damping ratio found in the vibration mode at 7.26 Hz, as shown in Figure 7, and the dynamic coupling between the diagonal and lower chord members. The dynamic coupling between the diagonal and lower chord members are represented by the ratio of the modal amplitude of the diagonal member to the modal amplitude of the lower chord member in the figure. The modal amplitude of the diagonal member was obtained by subtracting the modal amplitude at the end of the diagonal member from that identified for the measurement location in the diagonal member.

**Figure 8** Relation between changes in modal damping ratio and dynamic coupling between diagonal and lower chord members. (a) modal damping ratios and (b) amplitude ratios of diagonal member to lower chord member in local and global vibration modes before and after reinforcement.

The vibration mode at 7.14 Hz shown in Figure 8 was the local mode dominated by the motion of the damaged tension diagonal member D5 as indicated by a high amplitude ratio of the diagonal member to the lower chord member (i.e., about 30). As shown in Figure 7, the modal frequency of the local mode

increased from 7.14 Hz to 9.80 Hz after the reinforcement of the diagonal member: the modal properties of the mode after the reinforcement are not shown in Figure 8.

The decrease in the amplitude ratio of the diagonal member D5 to the lower chord member from about 16 to 0 in the global mode at 7.26 Hz, as shown in Figure 8, implies that there was no dynamic coupling between the diagonal member D5 and the lower chord member after the reinforcement due to the increase in the modal frequency of the local mode of D5. The decrease in the modal damping ratio of the global mode at 7.26 Hz may be associated with the loss of coupling between the diagonal and lower chord members that was caused by the change in the mechanical property of the diagonal member. This finding suggests that the modal damping ratios of global modes may be used as an indicator of local damages in diagonal members in steel truss bridges.
