STRUCTURAL REMEDIATION & RETROFIT OF DISTRESSES PRECAST-PRESTRESSED 'T' BEAMS OF A PUBLIC UTILITY BUILDING, IN COLOMBO, SRI LANKA. – A SITE CASE STUDY.

¹Dharmika Wimalratna, ²Sandeep Savardekar

¹Principal Consultant, Navcorp Engineering Consultants, Colombo, Sri Lanka.

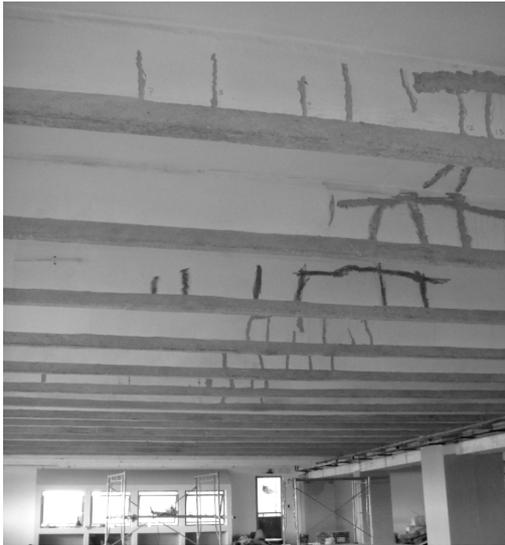
The distresses to the prestressed-precast beams in the form of cracks were jointly investigated by the concerned authorities and academicians of University of Moratuwa. The cracks observed were typical flexural crack patterns as shown in Figure 2. The details of the structural investigation and repair retrofit design are not in the scope of this paper and hence are not elaborated upon herein. Briefly, the structural investigation concluded that the distresses in the form of cracks to the beams was due to the impact and event overloading caused by the evacuation of various bulky office equipment from the upper floors of the tower portion onto the roof of the lower rear portion, during the firefighting

Figure 2. : View of beams showing typical flexural crack patterns.

operation. The investigations also deemed it necessary to carry out appropriate repair and retrofit measures to bring the distressed beams back to a satisfactory service level.

In view of the above criteria it was imperative that the repair and retrofit system to be put in practice should be non-intrusive, quick, discreet and one which does not impose any additional loads onto the elements. The use of conventional techniques such as concrete jacketing or steel plate bonding for retrofit had been ruled out because of their invasive, time consuming process and additional dead loads. Thus, the repair technique recommended was surface mounted, multi-port low viscosity epoxy resin injection into the cracks, whilst the retrofit technique recommended was carbon fibre reinforced polymer (CFRP) wrapping.

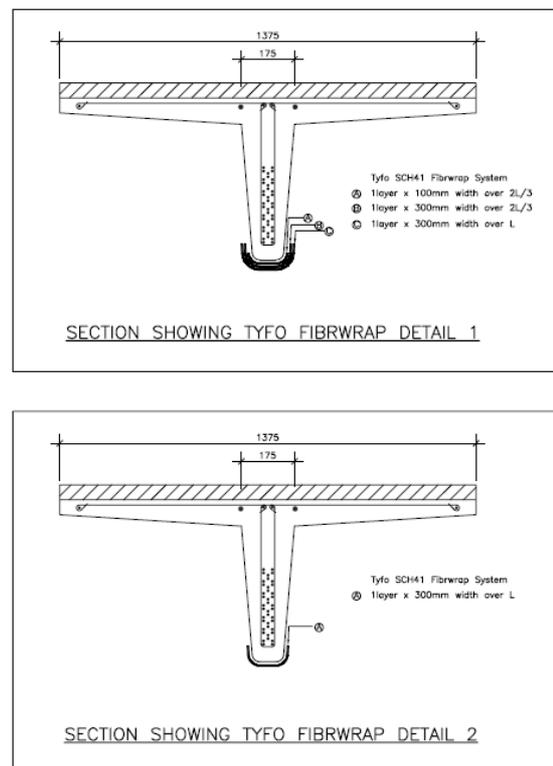
Out of the thirty five beams, four outer beams on each side of the building were found to be without any cracks. These beams were considered to be structurally sound and needing no remedial measures. The central eleven beams exhibited the most severe structural cracks whereas the remaining beams were having minor cracks. The repair process required injection to all such beams exhibiting cracking. Two separate CFRP retrofit schemes / details were designed for the central twelve beams categorized as severe cracking and the other remaining beams categorized as minor cracking. CFRP wrap details are given in Figure 3.

Figure 3. : CFRP wrapping details

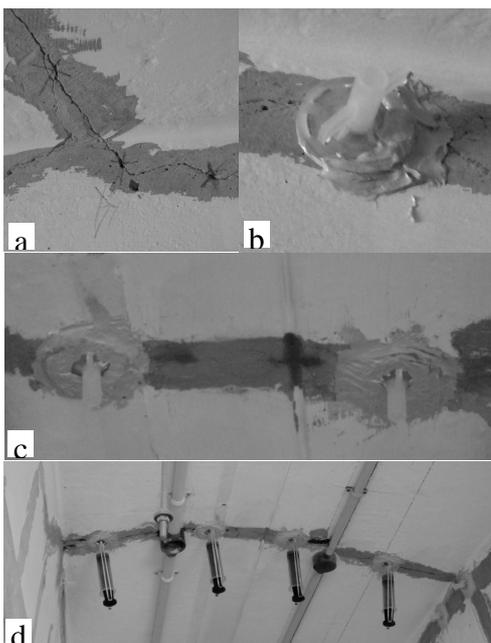
Figure 4: a) marking port locations. b) & c) fixing surface ports with epoxy putty. d) low pressure, multi port epoxy resin injection.

- The crack lines on the beams were identified and demarcated.
- Paint, surface finishes and other deleterious materials were removed by means of wire brushing or grinding to clean the crack line.

- Injection port locations along the crack line at appropriate spacing were then marked.
- Surface mounted injection ports were then fixed along marked locations with epoxy putty.

- The rest of the crack line was sealed with cementitious non-shrink grout.
- The two parts of epoxy resin were mixed in small batches according to the mix ratio as specified by manufacturer.

- The low pressure auto injector syringes were then filled with the mixed resin and fixed onto the installed port for auto injection.
- The auto injector syringes were replenished with fresh resin mix as and when they were depleted.

- Injection for a crack line continued until all the ports no longer accepted any more resin.
- Injected resin was allowed to cure and the ports were then removed.

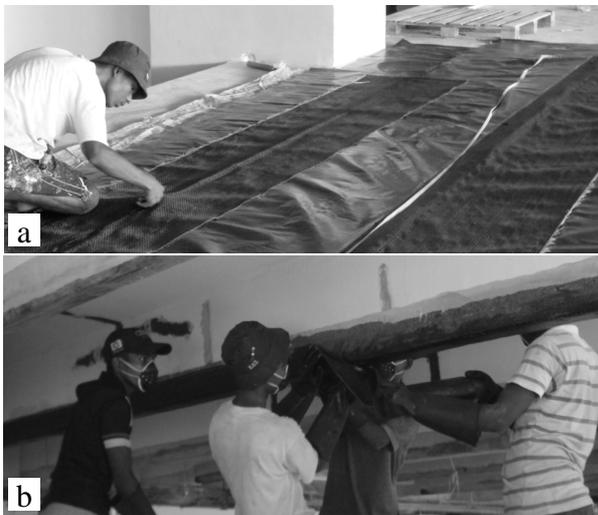
Figure 5. A) sizing carbon fibre fabric. B) installing saturated fabric onto element.

- The carbon fibre fabric was sized and cut to the required dimensions that were obtained from site measurements.
- The two components of the saturant resin matrix were mixed together in the ratio as per manufacturer's specifications.

- Sized fabric was then manually saturated from both sides with the mixed resin matrix.
- Saturation was carried out manually using fabric rollers.
- The saturated fabric was then rolled onto spools and taken to site for installation.

- Prior to installation of the CFRP wraps, the prepared surface was first wet primed with a coat of saturant resin.
- The saturated fabric was then installed onto the primed surface by evenly rolling out the spool along the primed surface.

- The CFRP strips were adhered onto the surface using uniform hand pressure along the main fibres, thus ensuring removal of any entrapped air voids behind the CFRP wrap.

- Additional layers were installed on wet strips to build up to the required number of layers as specified.
