# Investigation of damage on wall panels due to blast vibration

Department of Civil and Environmental Engineering

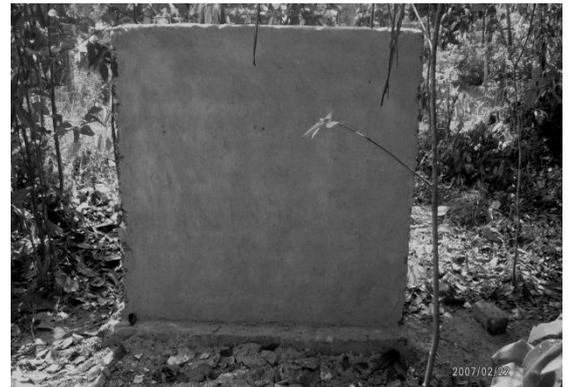
A brick wall panel having a size of 1200 mm × 1000 mm was cast at the selected quarry at Hapugala (Figures 1 and 2). The model brick wall panel was constructed using a rubble foundation and stretcher bond of 1:5cement: sand mortar. A 10 mm thick plaster with 1:1:9 lime:cement:sand was used. These variables were selected in order to be representative of the commonly maintained practices in Sri Lanka. A lime coat was painted on the dry plaster to create a clear surface on the wall panel. This was necessary for the clear observation of cracks propagation and any other possible damage to the experimental model structure.

Figure 2: Constructed wall panel

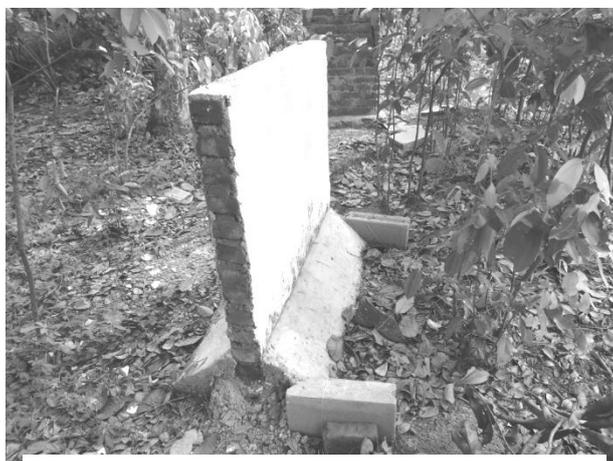
After observing initial damage, the damage was repaired and restored for further investigations (Figure 3).

Figure 3: After laying concrete at the joint

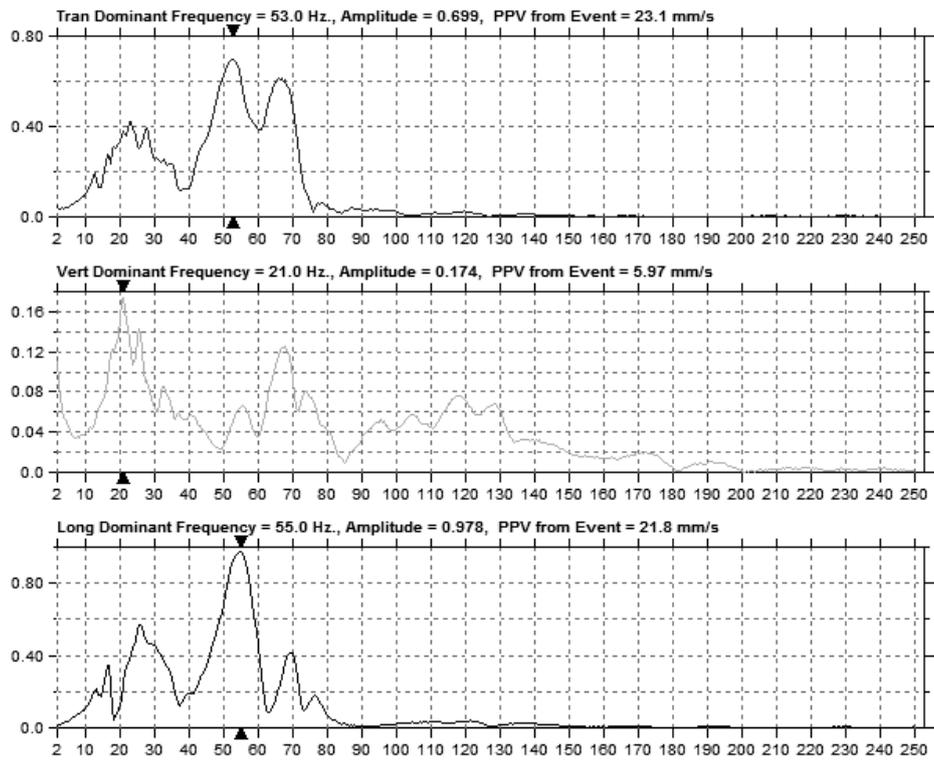
Continuation of blasting was resulted in a significant crack between the wall and the foundation at a vibration level of 30.2 mm/s of ppv. Figure 7 shows the frequency spectrum of the vibration in three measured directions. Frequency spectrum shows that the most of the energy of the signal concentrated at a frequency of 50 Hz. After the joint was concreted and restored, significant crack (i.e., a structural separation) was formed at the top level of the concreted foundation.

Figure 7: FFT report generated for the vibrations three

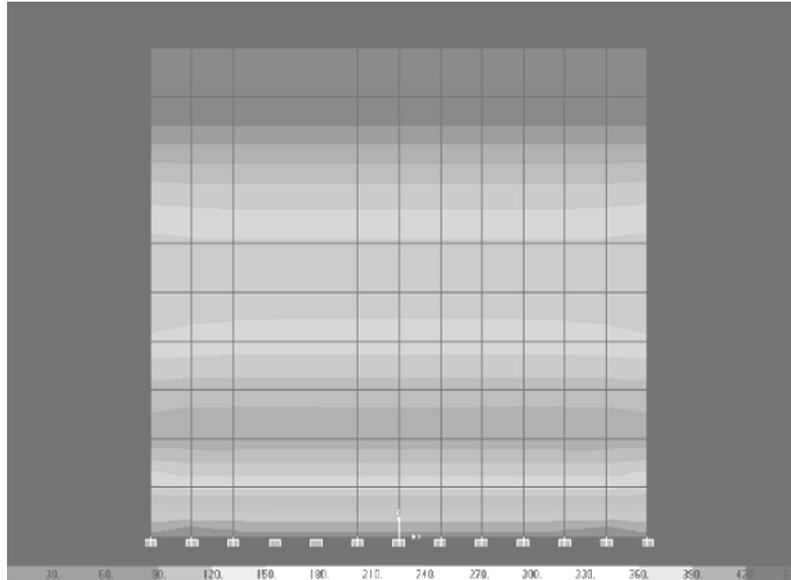
Figure 9 shows the stress distribution along the structure when exposed to the response spectrum of dynamic force. The results of the numerical model using SAP 2000 highlighted an increased S22 stress concentration of about  $420 \times 10^{-3} \text{ N/mm}^2$  at the bottom level of the structure.

**Figure 9: Stress distribution obtained from analysis**

From the numerical model, the increased stress concentration at the bottom level of the wall panel found from the FEM analysis also implies that there is a high possibility of damage at that level. An increased S22 stress concentration of about  $0.42 \text{ N/mm}^2$  observed at the bottom level of the plaster was closer to the splitting tensile strength of  $0.402 \text{ N/mm}^2$ . This implies that crack formed at the bottom of the structure was possibly due to the greater tensile stress developed at that level.
