ADAPTATION TO DISASTER: HOUSING IN FLOOD PRONE AREAS
WITH SPECIAL REFERENCE TO THE COLOMBO DISTRICT

A dissertation presented
to the
Faculty of Architecture
of the
University of Moratuwa
for the
MSc. (Architecture) Examination
Electronic Theses & Dissertations
www.lib.m May 2000

Wathsala Sepalage
Department of Architecture
University of Moratuwa
Sri Lanka

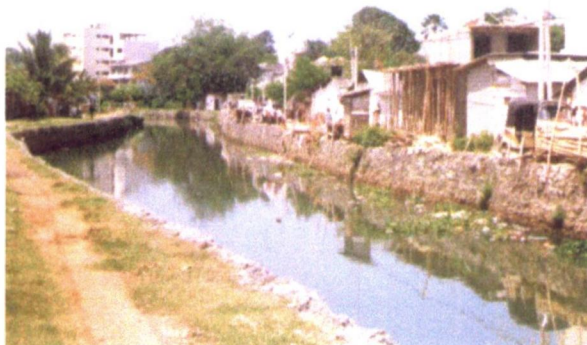
Fig. 3. Shanties built on canal reservations. These pose obstructions to the proper drainage of floodwaters.

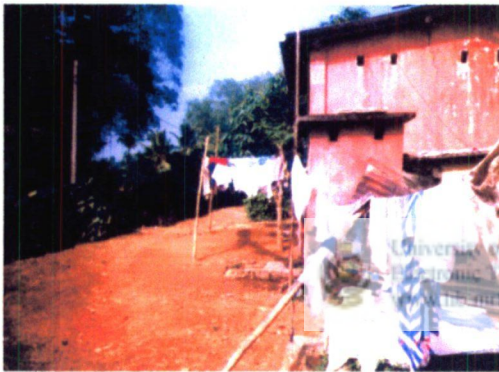
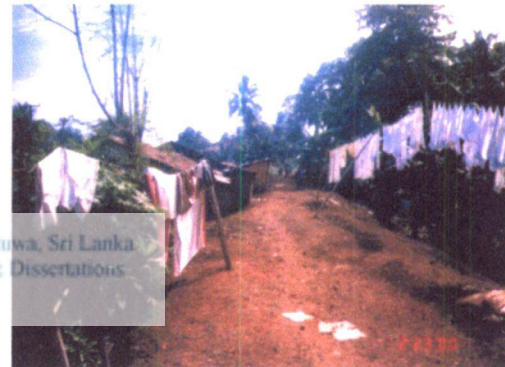
Fig. 15. Houses on the Flood Protection Bunds

Fig. 16. Houses on the Food Protection Bunds

The above (Fig. 15 and Fig. 16) show how low income settlements have developed along the flood protection bunds thus, not only are these houses situated in a very precarious location but they also impede maintenance activities of the Irrigation Department whose responsibility is to make sure that these bunds are in good order.

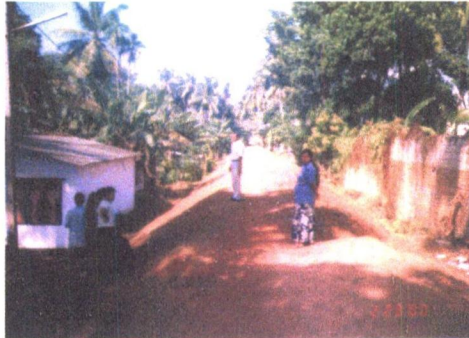
Fig. 17. House to be partially demolished.

This Particular section of the Bund has been selected for enlargement. But this house which is illegally placed will have to be partially demolished (Fig. 17).

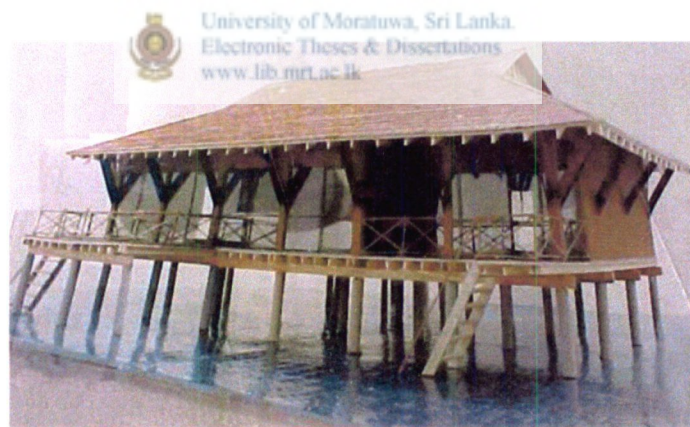
Fig. 37. 'Water Bungalow'

The 'water bungalow' is a proposal by Archt. Anura Rathnavibhushana, who wishes to build a house for himself and his family at Pita Kotte which is in a low lying marshy area. In this regard he is proposing a house on stilts (Fig. 37) which will be similar in appearance to those houses used in the Philippines and other Far Eastern countries. The particular site considered is part of a larger marshy area susceptible to floods during heavy rains. Therefore, the design opts to elevate the house in an attempt not to disrupt the natural conditions of the locality. The designer also proposes to excavate ponds within the site, so that during the rainy months the extra water can be collected in them, thus reducing the level of the flood waters to some extent. He also wishes to cultivate mangrove plants such as *kirala*, *kadol* and the many species of water lily in attempt create a habitat for various water fowl and other animal species common to this type of environment. Therefore, on the whole it appears that this proposal aims to find an environmentally friendly solution to building a house in a flood prone site.

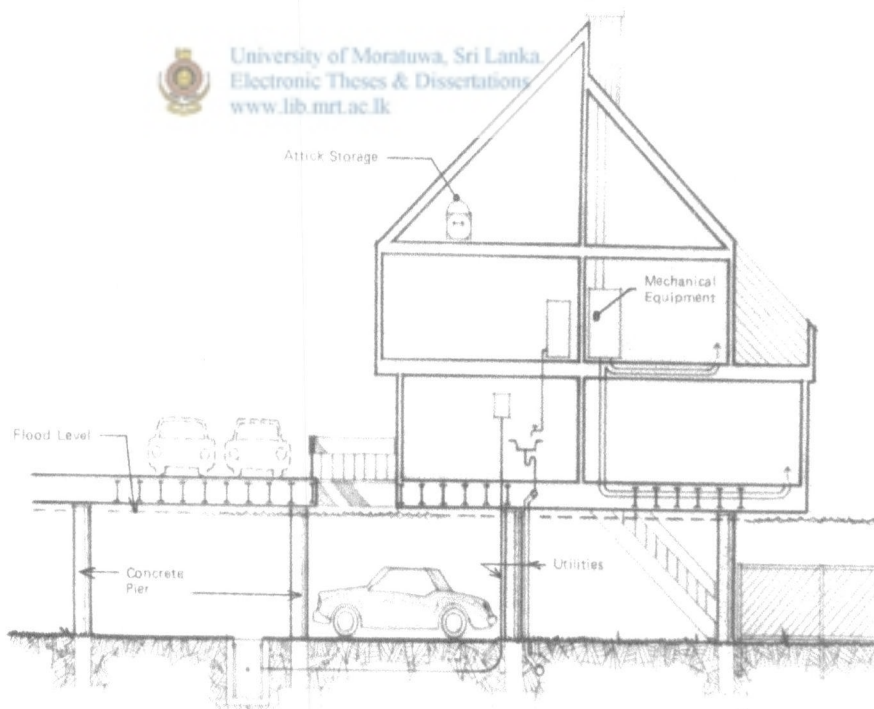
Fig. 39. Luxury Town Houses - Bridgeport, Connecticut
Site layout & Section

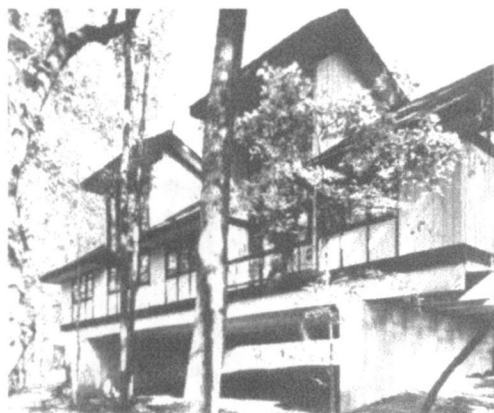
Fig. 49. Elevation by shear walls

Shear walls are more suited for massive structures like apartments or hotels, but can also be used for smaller residential structures (Fig. 49). Shear walls act as deep beams in resisting forces in the plane of the wall. Since shear walls have low resistance to lateral forces, they should be only used in areas subject to low to moderate velocity flooding. Shear walls should always be placed parallel to the expected flow of flood waters.

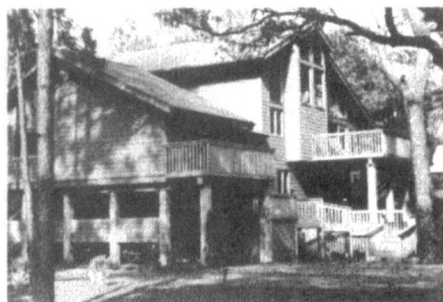
Fig. 50. Elevation by posts

Post foundations use long slender wood, concrete or steel posts fixed in pre-dug holes. The cross section of the posts can be round, square or rectangular though the latter shapes are preferred for they are easier to frame into than round ones.

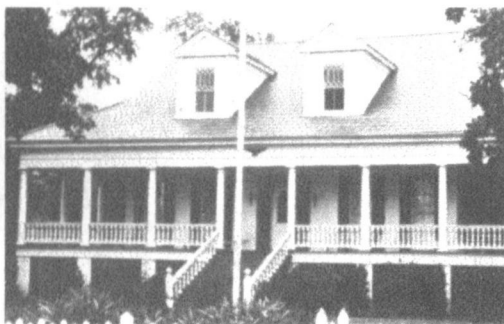
Fig. 52. Elevation by piers
Source: FEMA 54 (March 1994). p. 74

Piers are best suited for areas away from a river or coastline where flood waters move with low velocities. Therefore, these are the best type to be used in urban areas subjected to local or standing floods. Pier foundations use brick, concrete masonry blocks or poured in place concrete to elevate structures.
