REDUCING NON- REVENUE WATER TO IMPROVE PIPE BORNE WATER SUPPLY IN PANADURA - HORANA REGION

“This dissertation was submitted to the Department of Civil Engineering of the University of Moratuwa in partial fulfilment of the requirements for the Master of Science in Construction Project Management”

Department of Civil Engineering

University of Moratuwa

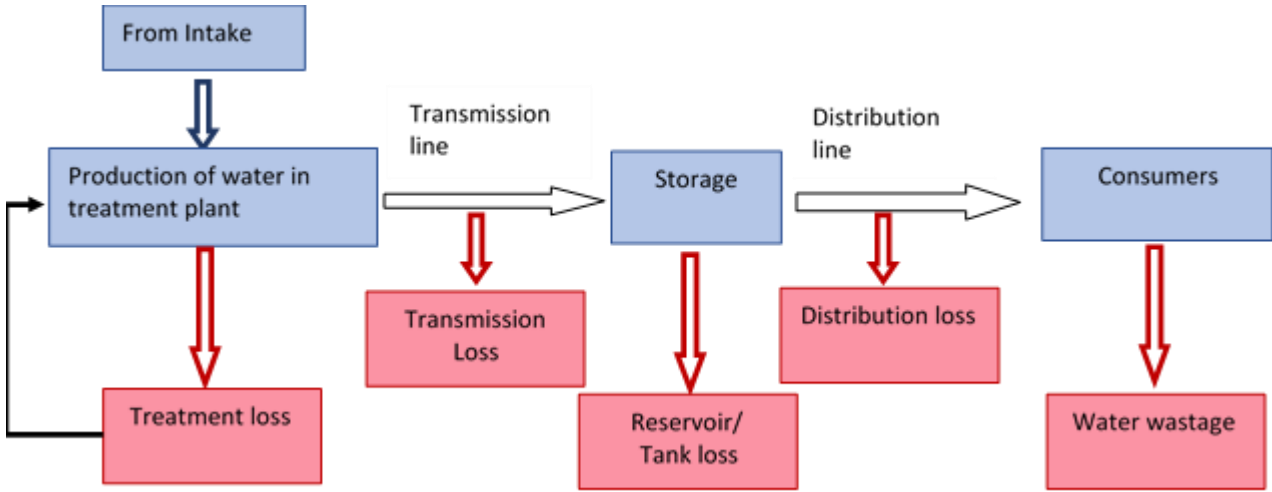
Figure 2.3 : Means of Water Losses in Water Distribution Processes

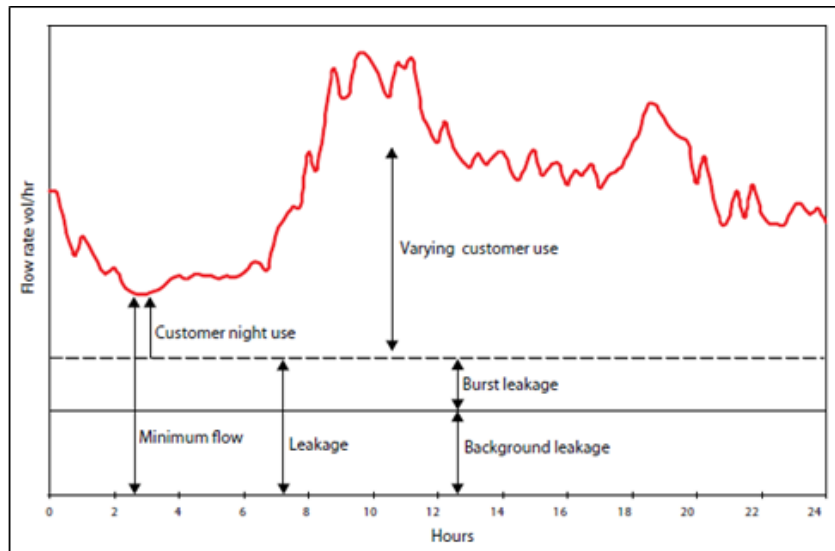
Accordingly, estimating the leakages in the MNF period is carried out by subtracting legitimate night uses from the MNF (Farley and Trow, 2007).

Figure 2.8 : Typical 24-hour DMA flow profile indicating MNF.

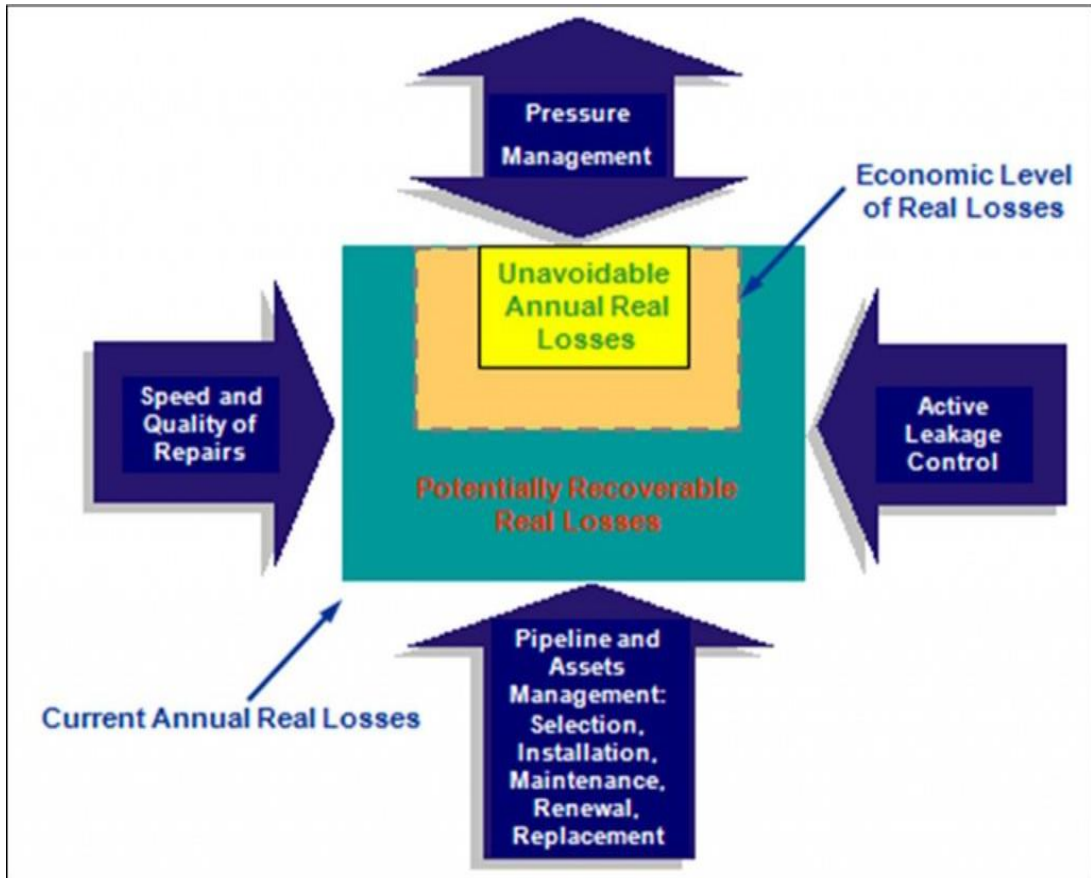
According to IWA (2003), real losses cannot be eliminated completely. The lowest technically and practically achievable annual real losses value is known as Unavoidable Annual Real Losses (UARL). This is demonstrated by the Figure 2.10.

Figure 2.10: The four-basic method of managing water loss

The Figure 2.10 shows the relationship between Current Annual Real Losses (CARL), which is represented by the larger rectangle and UARL, represented by the smaller rectangle. Each of the four component methods of controlling real losses, according to Farley and Trow (2003: p 42), influences leakage in specific way or manner. Long term pipe line management influences the numbers of new leaks that develop each year while pressure management influences the frequency of new leaks and flow rates of bursts and leaks. In the same way, the average duration of leaks is influenced by the speed and quality of repairs and active leakage control determines how long unreported leaks can run before being detected (Farley and Trow 2003: p 42).

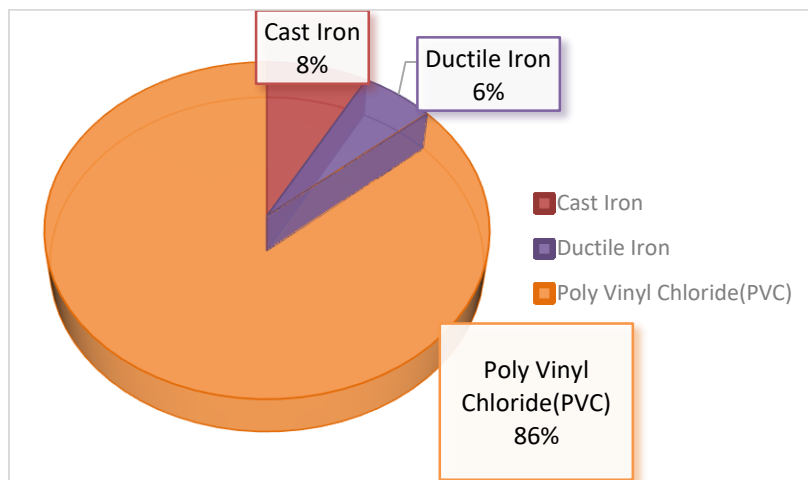
The network consists of different kinds and age group pipes as mixture of Cast Iron (CI), Ductile Iron (DI), Un-Plasticized Poly Vinyl Chloride (uPVC) and Asbestos Cement (AC), All new pipe extensions are mainly in uPVC and DI. Figure 5.2 shows the different proportions of each pipe material makes up in the Panadura- Horana water supply system.

Figure 5.2: Pipe Material Composition by Percentage

Accordingly, most of the pipelines in Panadura- Horana water supply system are the uPVC i.e. 86%.

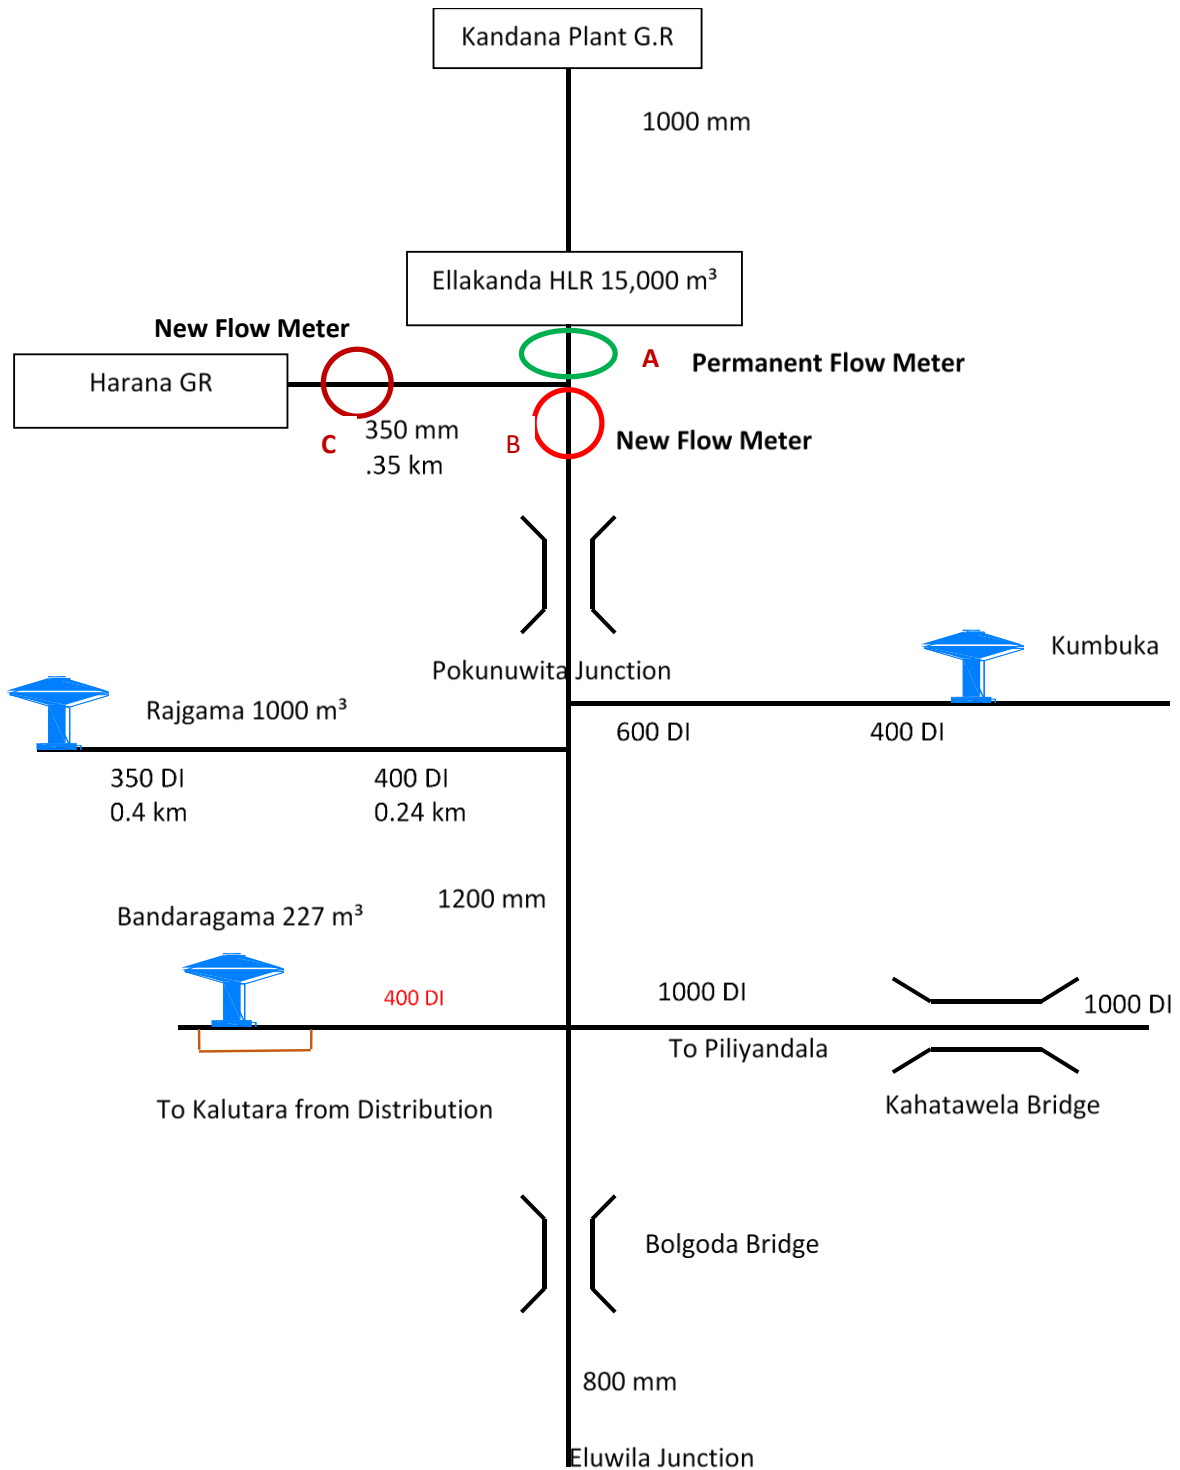
Due to high NRW in 2017 and 2018, research was initiated to find out the reason for this deviation. For that, out flow meter of Ellakanda reservoir was checked with Ultrasonic Flow meter. This detail is illustrated in the Figure 5.10.

Figure 5.10 : Network diagram for Panadura- Horana water supply system

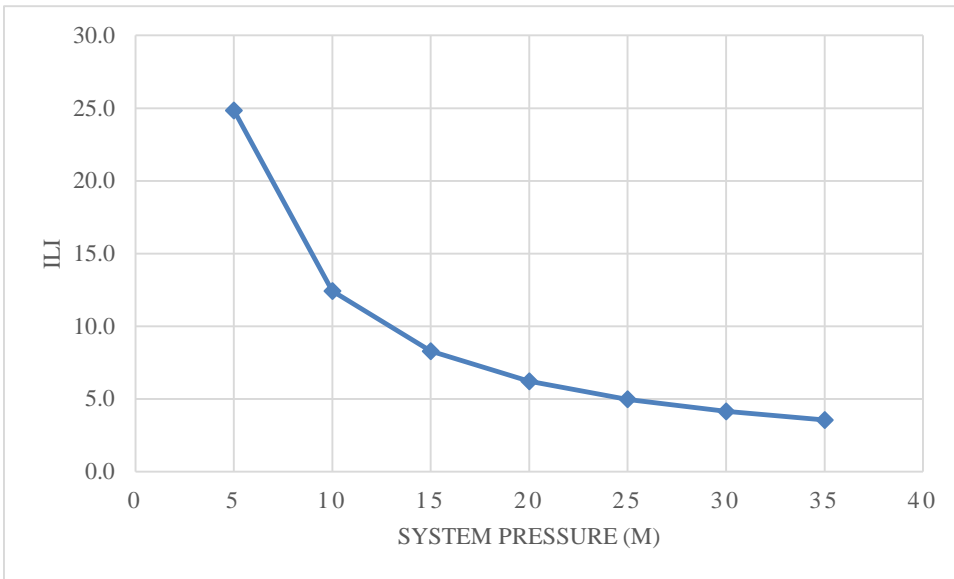
It was noted that the average system pressures vary from 0 to 35 m in the Panadura – Horana region. This ILI index only indicates the average picture of the entire distribution system. In order to assess the branches and to get the correct picture, ILI was calculated according to the system pressure as shown in Figure 5.12.

Figure 5.12 : Relationship between ILI Vs Distribution pressures in Panadura – Horana region

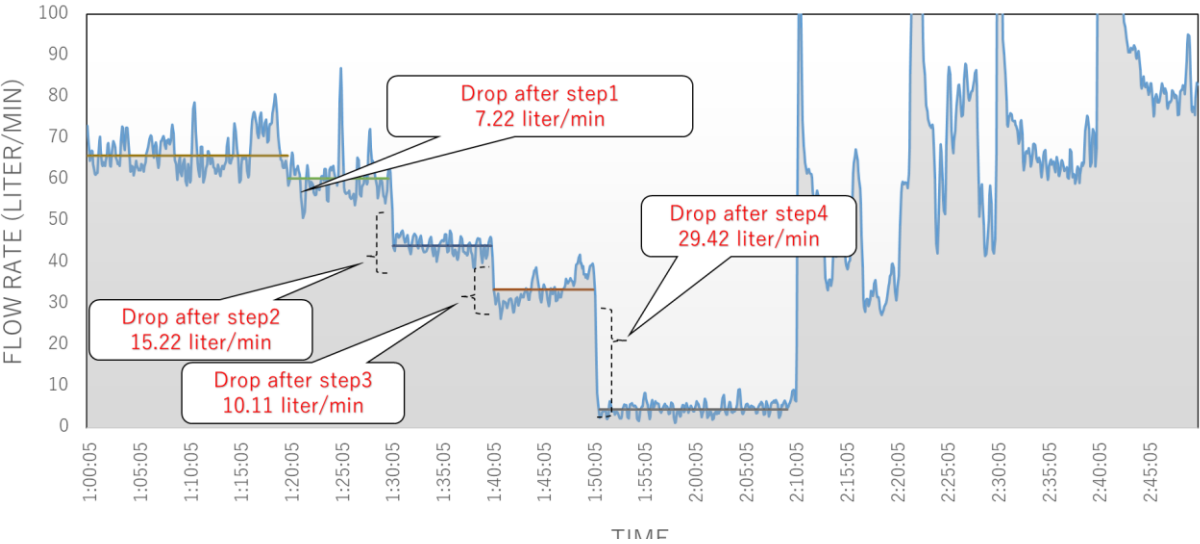
Figure 5.15 : Input Flow Rate of Step Test in Kaduruwuwa

Result of the test is like a step. It is called step test. However, during the test, it was observed that order of main leak from high to low as subzone 4, subzone 3, and subzone 2 and subzone 1 respectively.

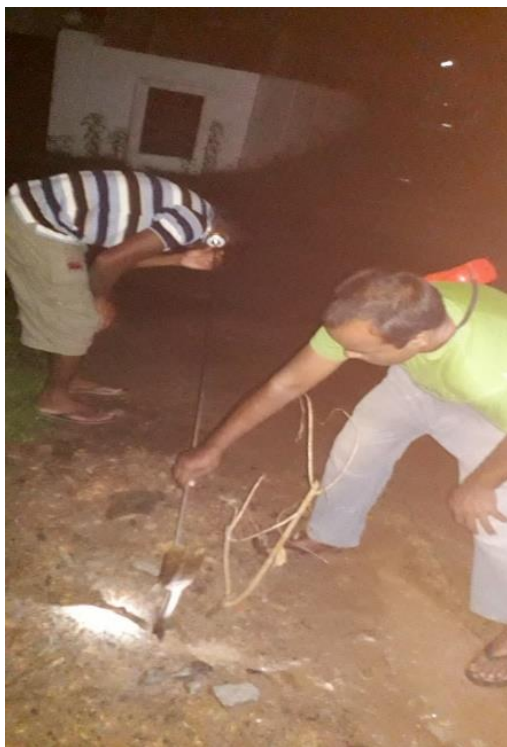
Figure 5.17 : Detection of Underground leak

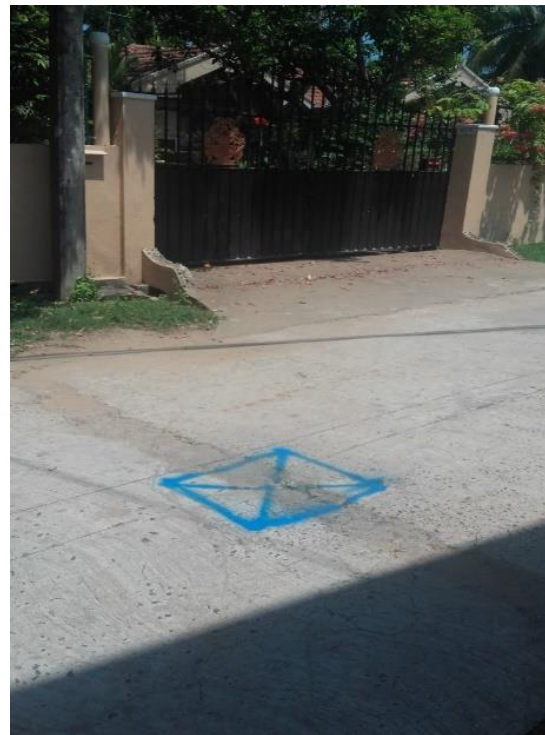
Figure 5.18 : Marked detected leak point

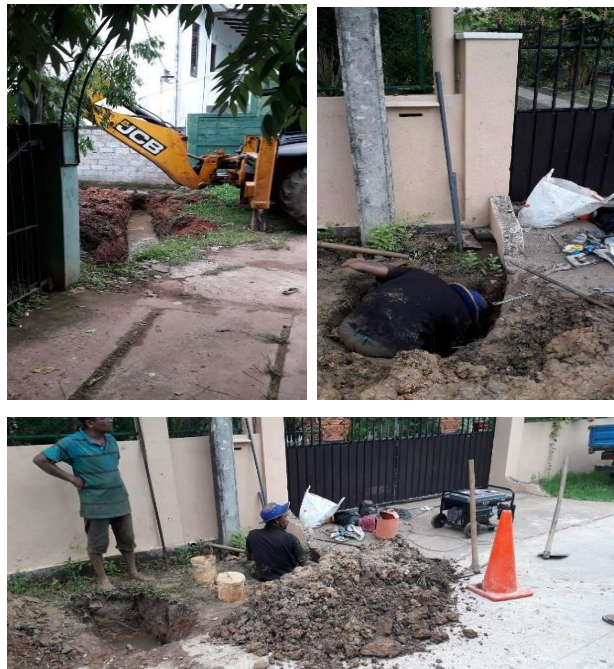
After the detection of underground leaks, leaks were repaired as shown in Figure 5.18.

Figure 5.19 : Repair of leakage

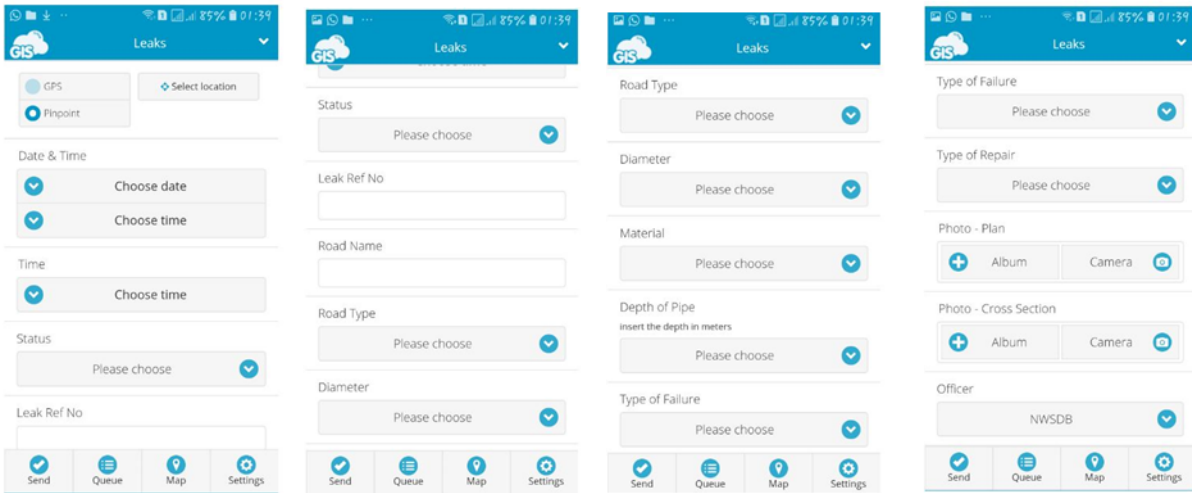
Leak locations were marked in GIS Cloud which is one of mobile application. In this application leak location was updated in the site. It included GPS location, Time of repairing, Reference number of leaks, Road name, Road type, Diameter of pipe, Material of pipe, depth of pipe, Type of failure, Type of repair and Site photos as shown in Figure 5.19.

Figure 5.20 : Process of updating the leak details

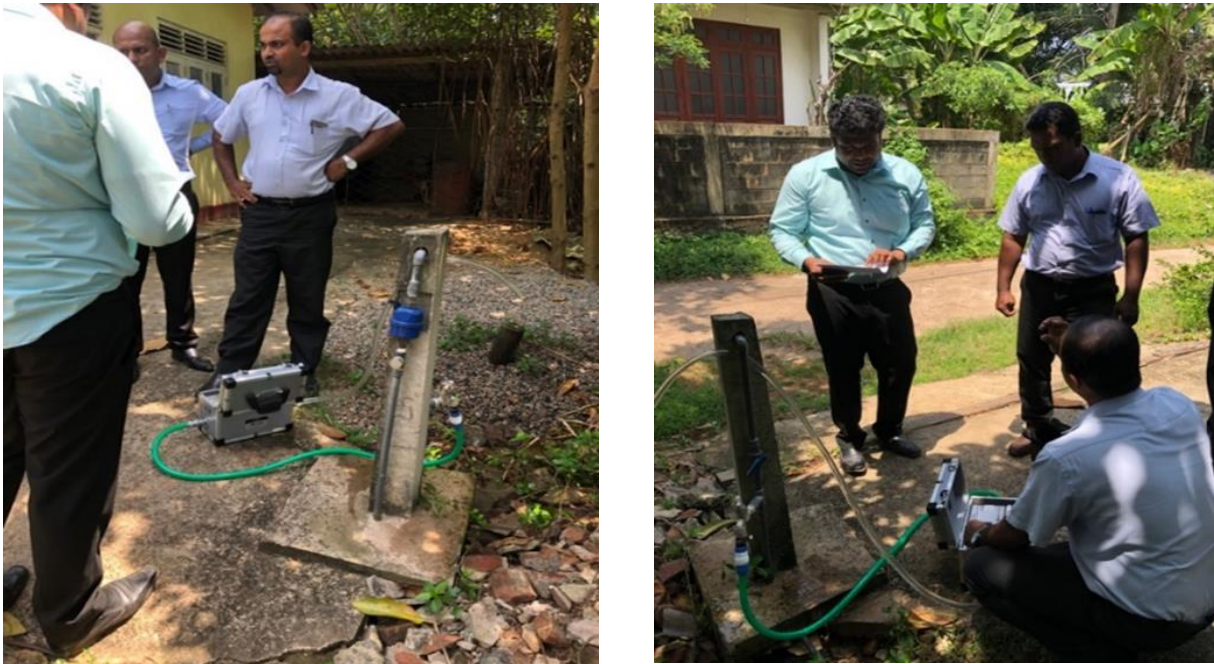
In the DMA 4, meter accuracy for 16 houses was checked with Electronic test meter. Table 5.18 shows the summarized details of house meter reading.

Figure 5.22 : Meter Accuracy test

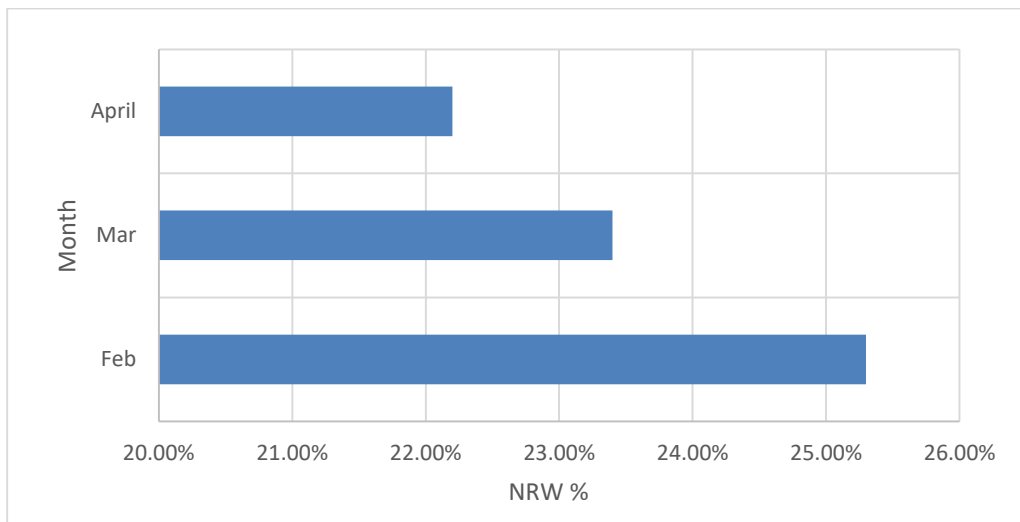
NRW percentage in field study area is gradually reduce with the progress of studies as shown in Table 5.19 and Figure 5.22. To tabulate this table, monthly NRW percentage reducing from February 2019 to May 2019 due to close monitoring in the study area.

Figure 5.23 : NRW percentage in Field study area from February 2019 to April 2019
