ANALYSIS OF SURFACE FLASH OVER OF 33 kV INSULATOR DUE TO SALINE POLLUTION

A Dissertation submitted to the
Department of Electrical Engineering, University of Moratuwa
in partial fulfillment of the requirements for the
Degree of Master of Science

by
N.H.C.JANAKA

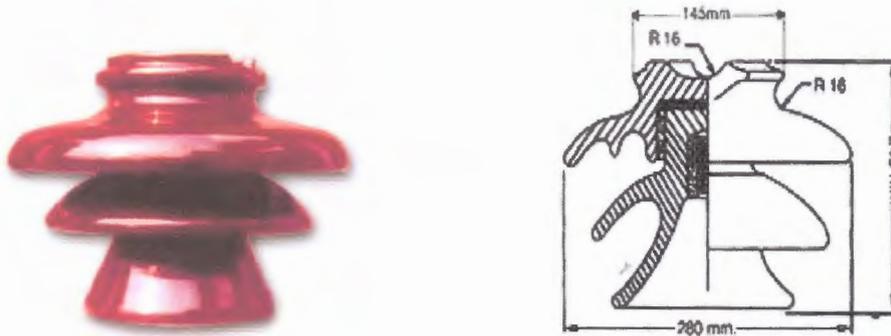
Figure 3.3 Pin Type Insulators

Pin type insulators are being adapted in medium voltage CEB distribution network all over the country for years.

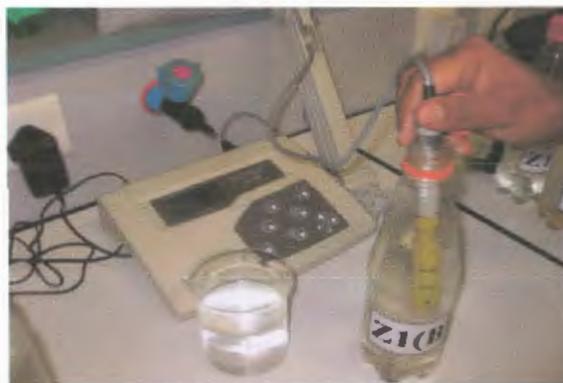
Sample solutions collected having washed the contaminated insulators is subjected for conductivity test. Specification of the conductivity meter is attached in Annex-3.

Figure 4.2 Conductivity Test Meter

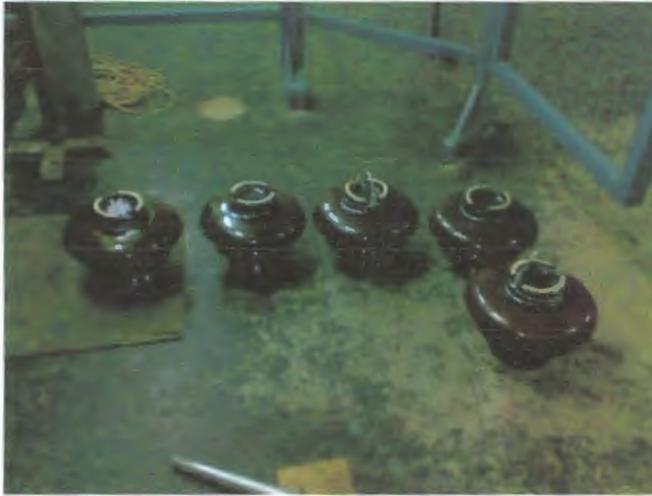
Figure 4.3 Sample Insulators before Testing

Five sample insulators as shown in Figure 4.3 applied with different salt levels to represent the contamination were undergone for power frequency test and thereafter the impulse tests as shown in Figure 4.4. This process was repeated for 3 attempts at each test and data were recorded each time to calculate the average value. In each attempt insulators were damped with water spray and thereby created artificial wet condition in the laboratory.

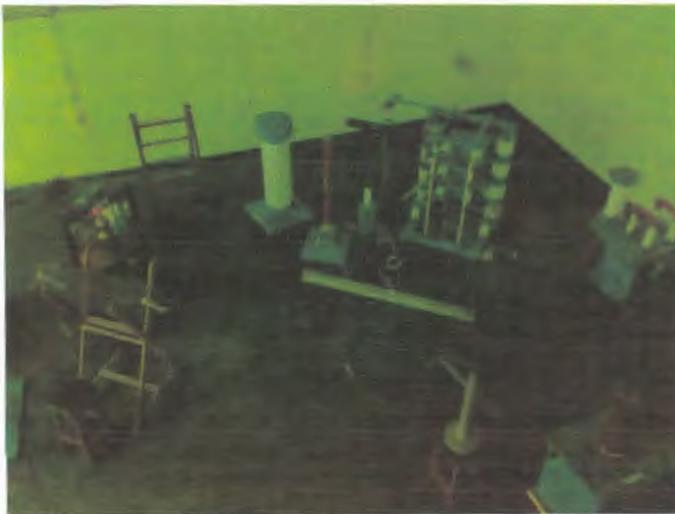
Figure 4.4 Power Frequency and Impulse Test in Laboratory condition
