# **IDENTIFICATION OF DAMAGES TO BUILDING STRUCTURES DUE TO ROOTS OF TREES**

R U Halwatura, V.G.N.P.Jayawardena, H.M.C.C.Somarathna

Department of civil Engineering

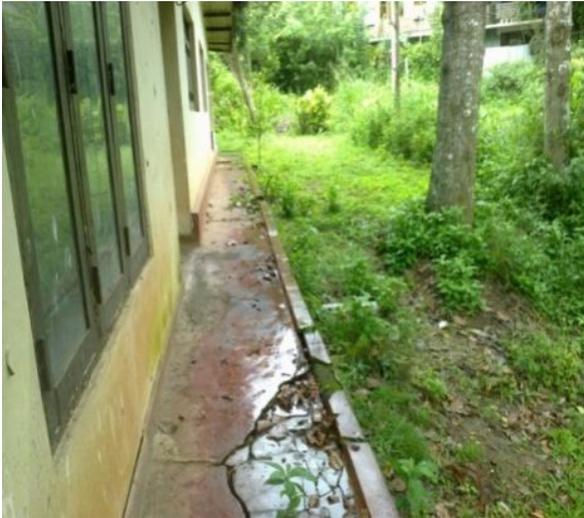
*Figure 1 -damage to pavement due to tree roots.*

Figure 1-4 illustrates damage types on nearby structures due to tree roots and they were taken when the detail survey was in progress. Survey was carried out in the above mentioned district and the structural cracks were recorded together with the distance and the criticality of the damage. The pilot survey revealed that lots of people in Sri Lanka don't have much awareness on safe planting distances.

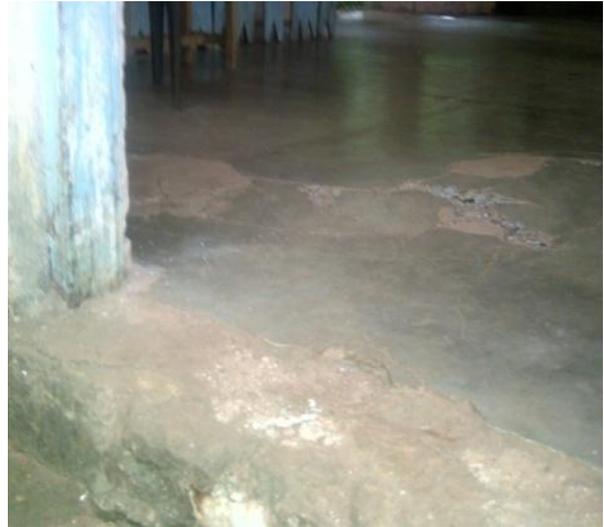
*Figure 2 -damage to floor due to tree roots.*

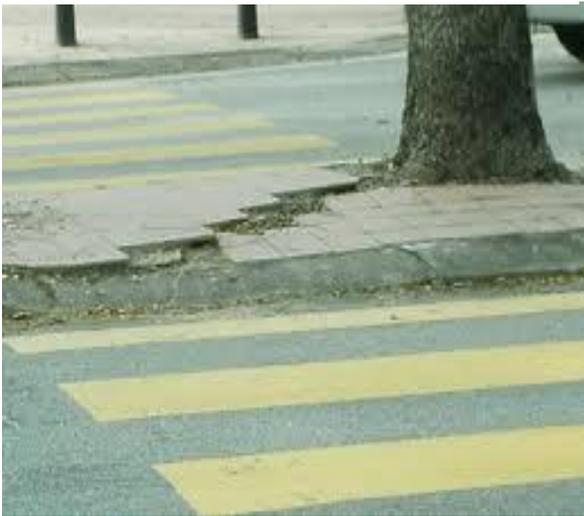
*Figure 3 -damage to road due to tree roots.*

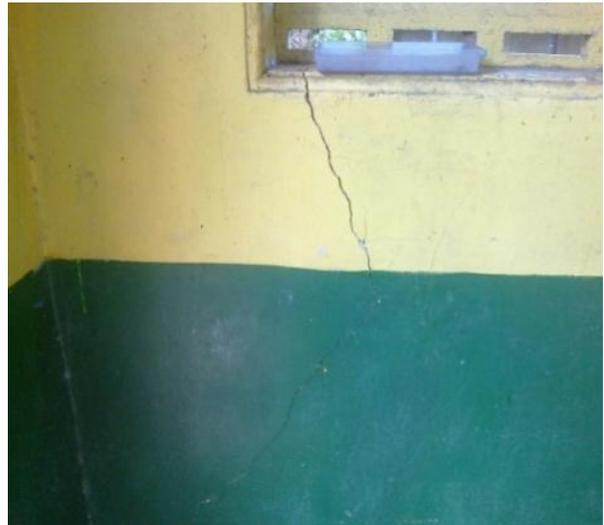
*Figure 4 -damage to wall due to tree roots.*

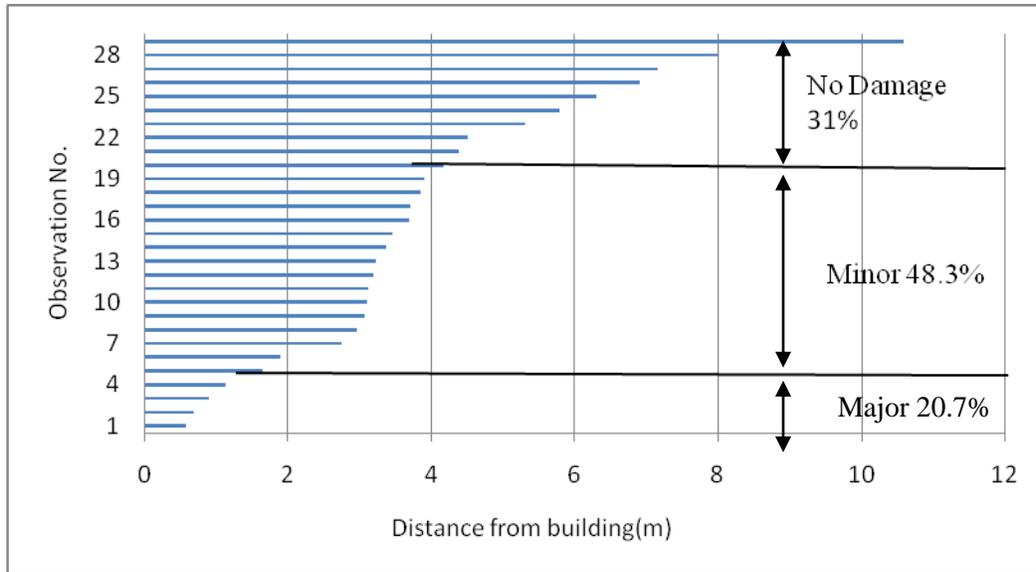
**Figure 5-Jack tree**

Figure 5 gives the observations related to Jack trees. It is convinced that the damage has been more significant up to 1.88 m from the building for Jack tree. From 1.88 m to 4.16 m, the damage is less. Any distance more than 4.16 m, can be taken as the safe planting distance.

<b>Common Name</b>	<b>Botanical Name</b>	<b>Maximum root spread damage recorded (Meters)</b>	<b>Suggested min safe distance from property (Meters)</b>
Jack tree	AtrocarpusHeterophyllus	4.16	4.25
Mango tree	Mangifera Indicia	5.10	5.25
Bodhi tree	FicusReligosa	7.20	11.00
Royal Poinciana	DelonixRegia	6.45	7.00
Tamarind tree	TamarindusIndica	5.86	6.00

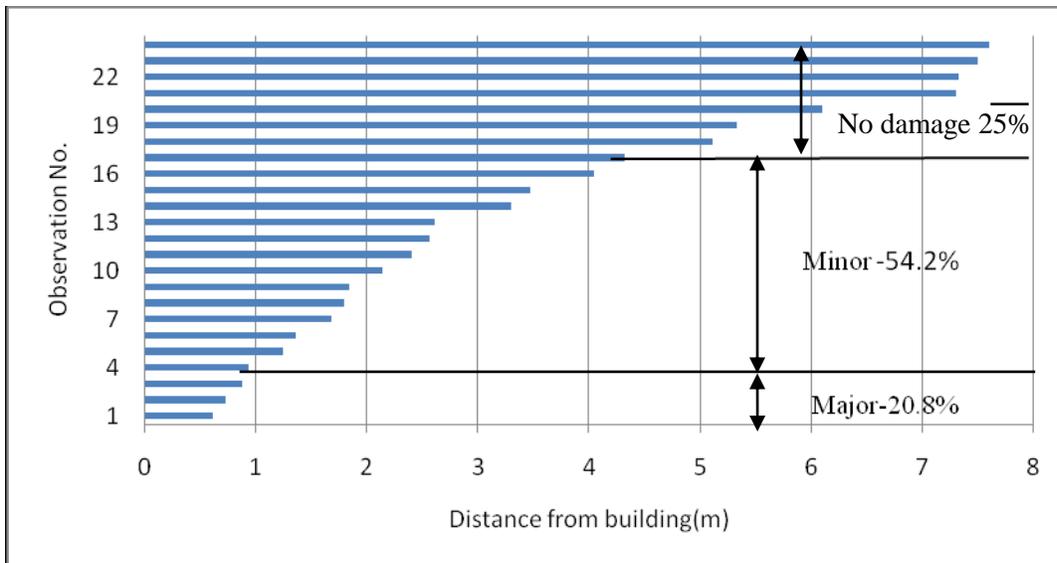
**Figure 6 -Mango tree**

Similar plot can be made for Mango tree and presented in Figure 6. The damage has been occurred significantly up to 1.24 m from the building for Mango tree. Then minor damaging range was from 1.24 m to 5.10 m. Any distance more than 5.10 m is in non-damaging range.

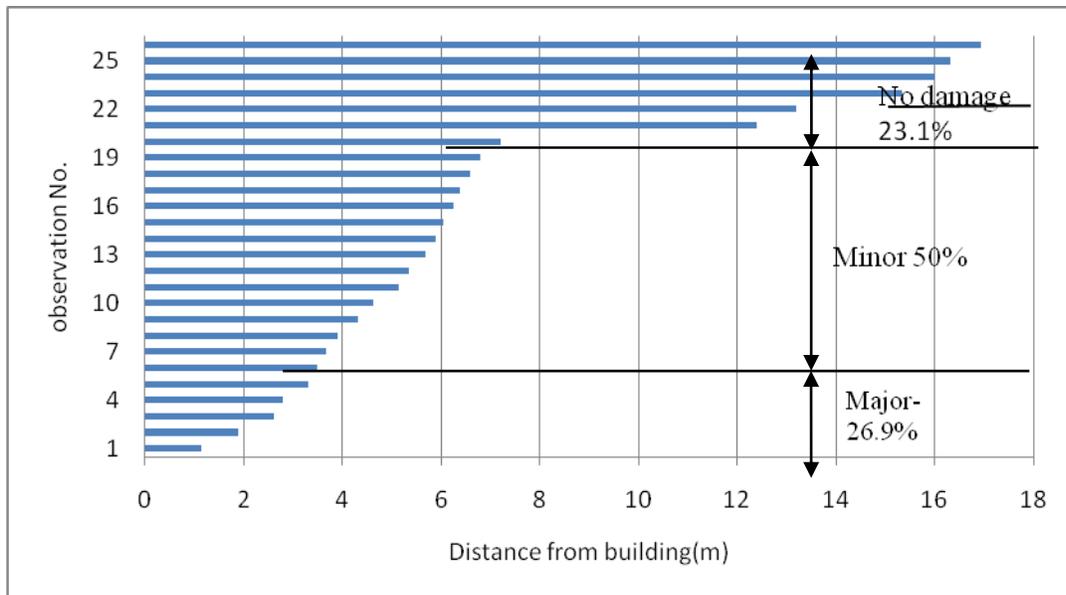
**Figure 7 -Bodhi tree**

Figure 7 shows the damage identification with respect to the distance and observations made for Bodhi tree. It is clear that the damage has been more significant up to 3.89 m from the building for Bodhi trees. From 3.89 m to 7.20 m, the damage is less. Any distance more than 7.20 m, can be taken as the safe planting distance for this type of tree.

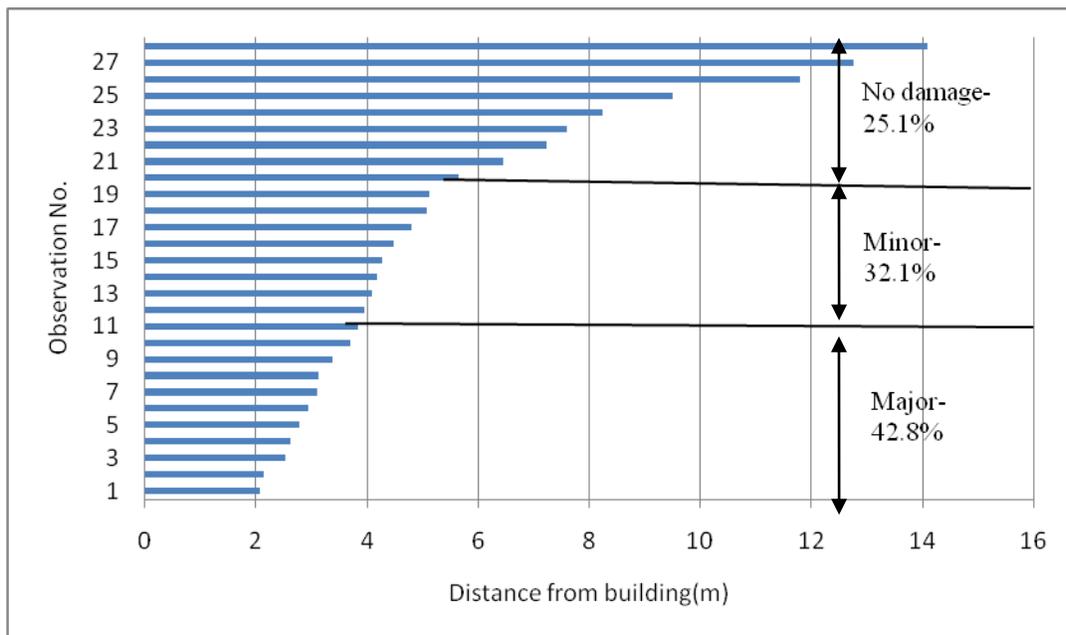
**Figure 8 -Royal Poinciana tree**

Figure 8 gives the damage classification based on the distance for Royal Poinciana tree. Here, the damage has been occurred significantly up to 3.94 m from the building to the tree. Then it range from 3.94 m to 6.45 m can be categorized as minor. Any distance more than 6.45 m is in No-damage range.

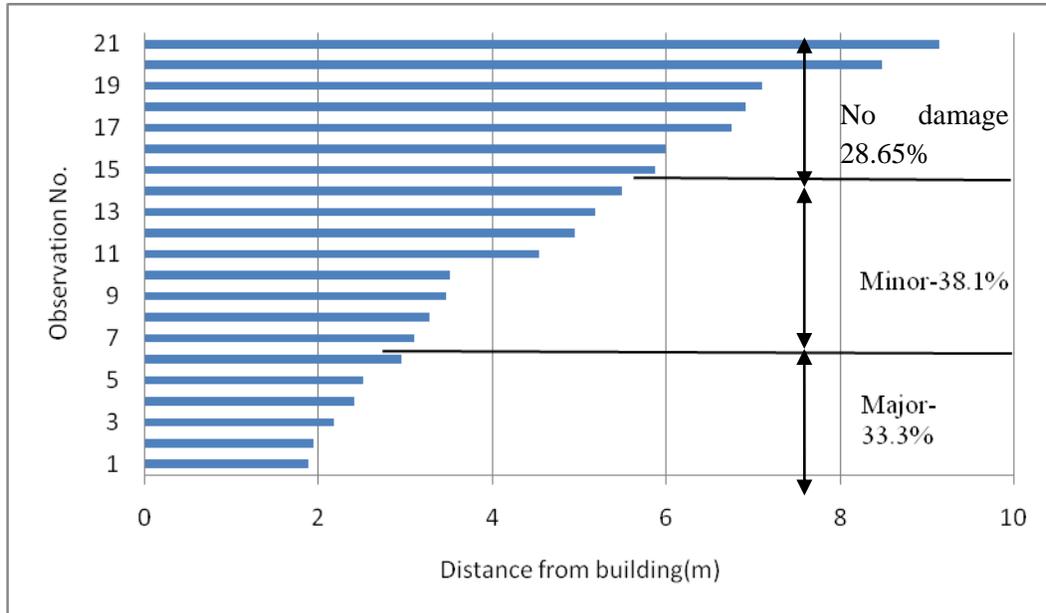
**Figure 9 -Tamarind tree**

For Tamarind tree, it is convinced that the damage has been more significant up to 3.09 m from the building. From 3.09 m to 5.86 m, the damage is less. Any distance more than 5.86 m, can be taken as the safe planting distance.
