# Experimental Investigation on the Behaviour of RC Panels Retrofitted with Polymer Coatings under Blast Effects

S. N. Raman

A series of experimental blast trials were conducted to evaluate the feasibility of using polyurea coatings in enhancing the blast resistance of RC panels. These blast trials, i.e. Vietnam Trial 2, were conducted in MyDuc Province in Hanoi, Vietnam, as a collaborative venture between The University of Melbourne and the Vietnam Institute for Building Science and Technology (IBST), Hanoi. The trials comprised of four spherical air blast experiment on one unretrofitted and three polyurea coated panels. The following sections describe the design, methodology, implementation and findings of the experimental programme.

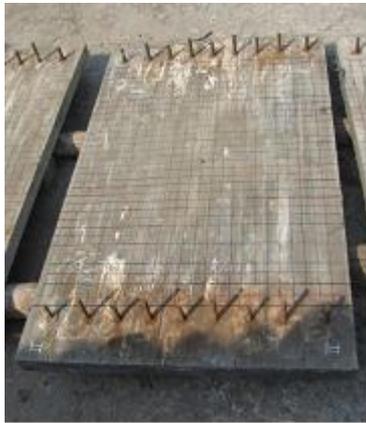
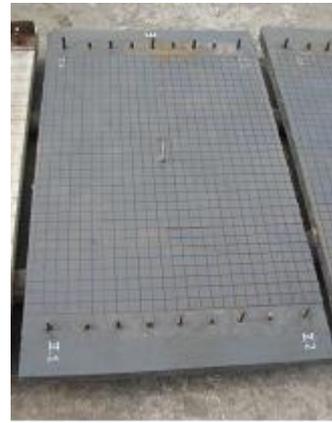
(a) Top (blast-receiving) face

(b) Bottom face

*Figure 2: Specimen PUB4 with 4 mm polyurea coating on the bottom face*

The four specimens were designated as UR2, PUB4, PUB10 and PUTB4. Specimen UR2 was the control unretrofitted panel, whereas PUB4, PUB10 and PUTB4 were subjected to polyurea coatings at different locations and with different thickness. Table 1 indicates the assigned designations, and the location and thickness of the polyurea coatings that were applied on each panel. The specimens were constructed and cured at the IBST facilities and were transported to the test site just prior to testing. Polyurea coatings on specimens PUB4, PUB10 and PUTB4 were applied by using a proprietary spray-on technique with high precision spraying equipment. The variations in the coating thickness and location were practiced in order to assess the contribution of these factors to the effectiveness of the retrofitting scheme and the overall response of the structural element. Figure 2 shows of the retrofitted specimen PUB4, with 4 mm polyurea coating on the bottom surface.

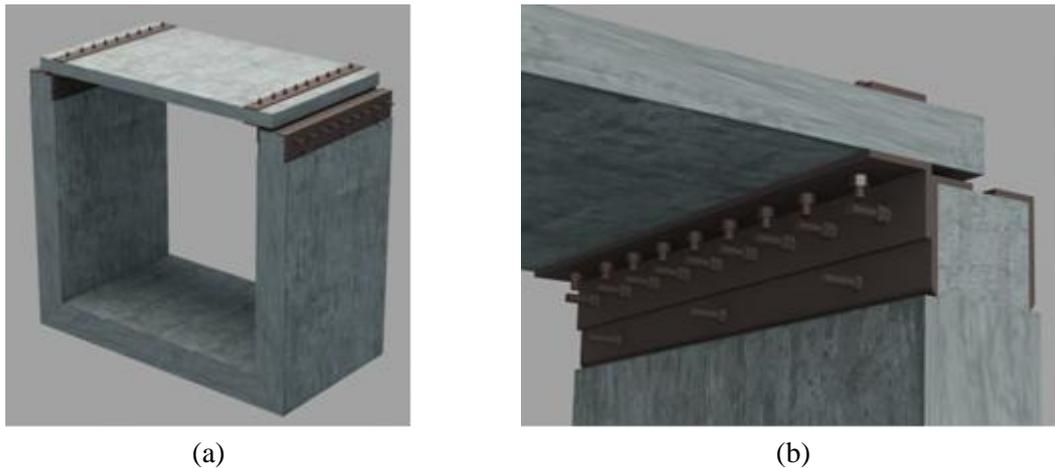
Figure 3: The: (a) test frame; and (b) specimen fixing assemblage

The test frame for the present research was constructed with RC of 100 MPa high-strength concrete (HSC) material (Figure 3a). The overall dimension of the test bunker was 1900 (L) × 1000 (W) × 1780 (H) mm, constructed with a 200 mm thick RC wall and base. 10 mm reinforcement was used to reinforce both the walls and the base of the frame (Figure 3a). The construction of the test bunker

was completed by building two 400 mm masonry brick walls at the two open sides of the test frame to reduce the clearing effects during the blast. The fixing assemblage utilised to install the test specimens onto the test frame was by angled cleat and bolt connections, as shown in Figure 3b. At each support, nine M20 bolts (vertical bolts) were used to attach the shorter span of the test specimen (1000 mm) to a  $100 \times 100 \times 10$  mm steel cleat (Steel Cleat A). Another nine M20 bolts (horizontal bolts) were then used to attach Steel Cleat A to a  $150 \times 70 \times 10$  mm cleat (Steel Cleat B). To attach the fixing assembly onto the test frame, two sets of Steel Cleat B were tied to the test frame using three M22 bolts (Figure 3b).

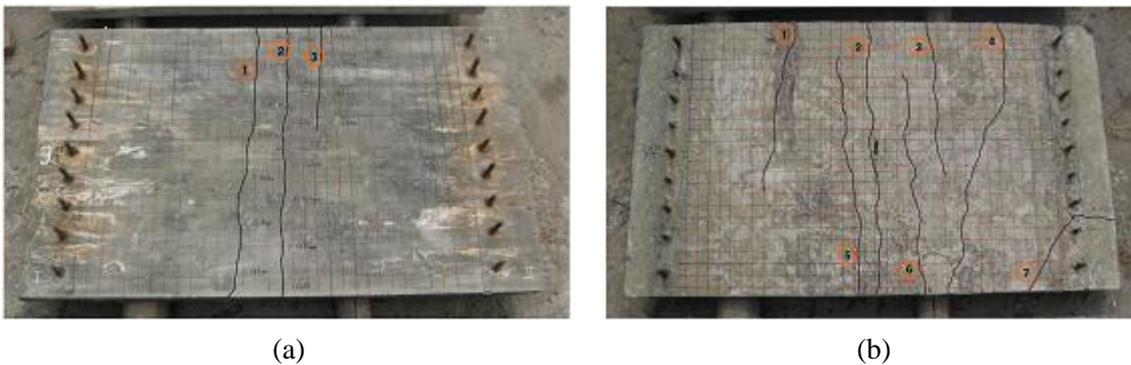
Figure 7: The crack patterns and crack widths on the: (a) top, and (b) bottom surface of specimen PUB4

The crack patterns formed on the top (blast-facing) and bottom surfaces of the specimen are presented in Figure 7. There were three cracks on the top surface, with the most critical crack located closest to the mid-span and recording an average width of 0.30 mm. This crack line stretched through the full length in the transverse direction of the panel. The remaining two crack lines recorded average widths of 0.11 and 0.16 mm, with only one stretching the full length of the panel. Meanwhile, more crack formations were observed on the bottom (polyurea coated) surface of the panel. However, only two out of the seven cracks stretched through the full length of the shorter span. One of the two was the most severe crack with a width of 0.31 mm, and similar to the previous

panels, it was located closest to the centreline of the panel. The average widths of the remaining cracks measured between 0.02 mm and 0.15 mm.

It can be observed that the polyurea coating resulted in a significant reduction in the level of damage of the panel, especially in terms of crack formation. While the crack widths recorded on both surfaces of specimen UR2 were severe, these were reduced to only minor cracks in specimen PUB4. It should also be noted that the cracks formed on specimen PUB4 were only surface cracks that did not penetrate through the thickness of the specimen, unlike the cracks formed on specimen UR2.
