DRASTIC IMPACTS OF 8TH OCTOBER EARTHQUAKE IN KASHMIR AND ROLE OF SUSTAINABLE DEVELOPMENT

Keywords: Kashmir, 8th October earthquake, sustainable development, infrastructure damages

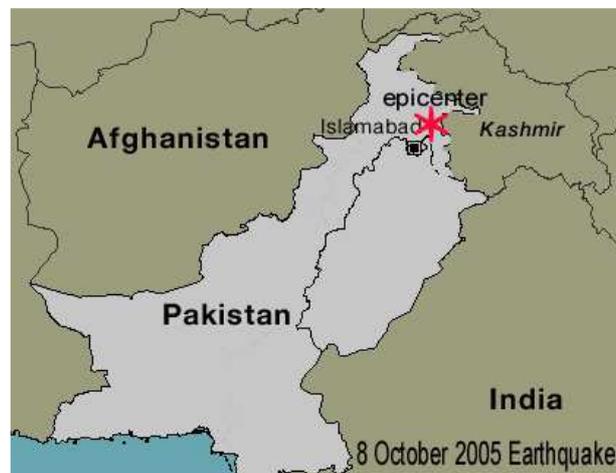
Figure 1: Epicenter of the 8th October Earthquake

The epicentre of the earthquake as shown in Figure 1 was located at latitude of 34.402 and longitude of 73.560. The earthquake has by now claimed over 22,288 lives and left 50,575 injured and caused heavy damage to many buildings in that area. The heaviest damage was observed in Muzaffarabad area where entire villages were destroyed. Buildings were also collapsed in Gujranwala, Gujrat, Islamabad and Lahore. The earthquake was also felt in Chakwal, Faisalabad, Jhang, Sargodha and even up to Quetta.

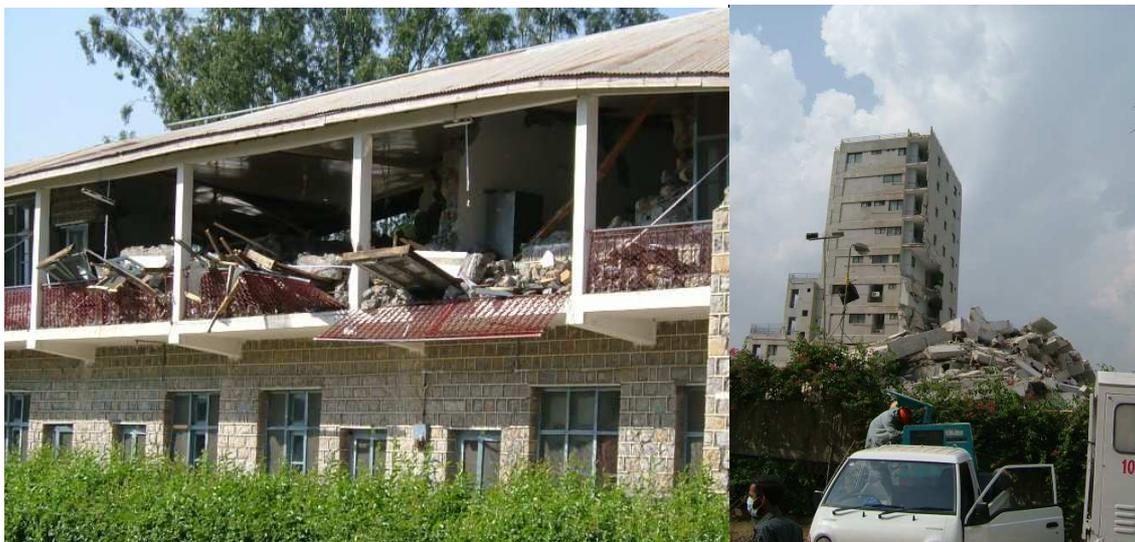
Figure 3: Destruction due earthquake at Islamabad and Abbottabad

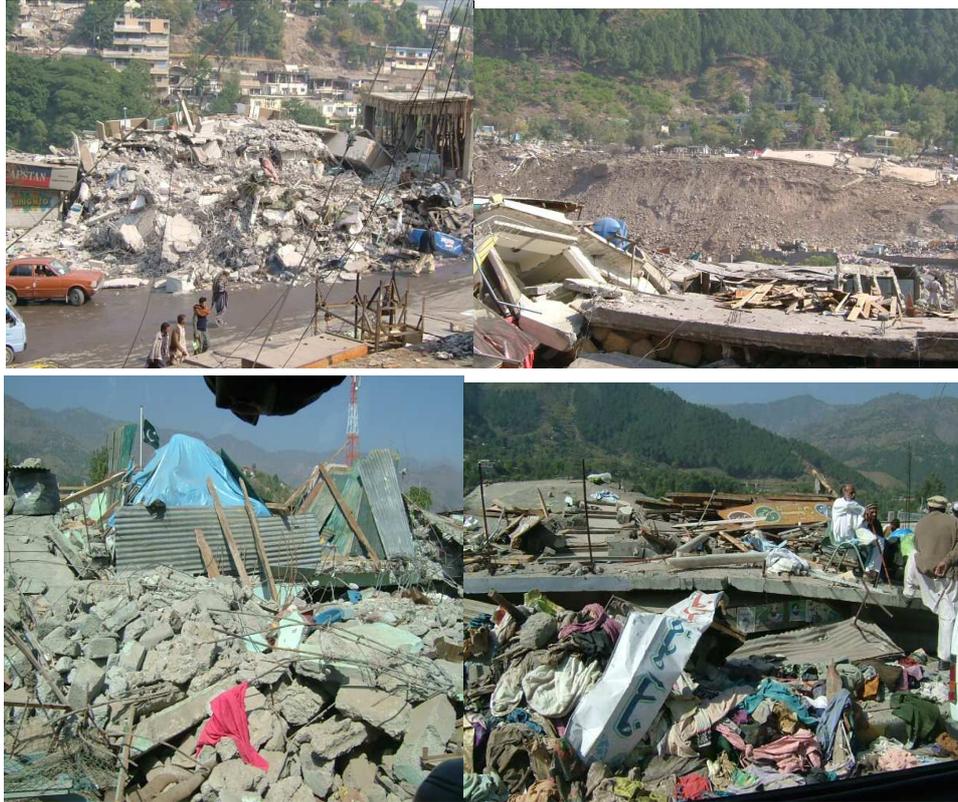
Figure 2: *Structural damages due earthquake*

During the field visit it was observed that most of the buildings were deteriorated due to old age, weathering effect and lack of maintenance. Wooden structures in the study area were severely deteriorated due to lack of maintenance and termite attack. The stone masonry structure behaviour is always brittle and it does not possess sufficient ductility which caused major damage in the study area.
