## REHABILITATION OF BLAST DAMAGED PRE-STRESSED CONCRETE BEAMS WITH FIBER REINFORCED POLYMERS (FRP)

**Abstract:** Damage to buildings due to blasts is a somewhat common occurrence in today's context. When such damages occur, one option is to demolish the structure and then to reconstruct. However, a better approach from sustainability point of view is to rehabilitate the damaged structure with suitable means so that a lot of materials and time can be saved while reducing the creation of heaps of construction waste. Since the damages due to blasts are not so common, it is worth reporting sustainability approaches employed in every such occurrence. This paper will present one such rehabilitation work that has been carried out for a complete floor consisting of pre-stressed concrete beams with pre-tensioned wires that suffered heavily due to extremely high loads caused by a blast that occurred directly above it when a small plane carrying explosives was shot down.

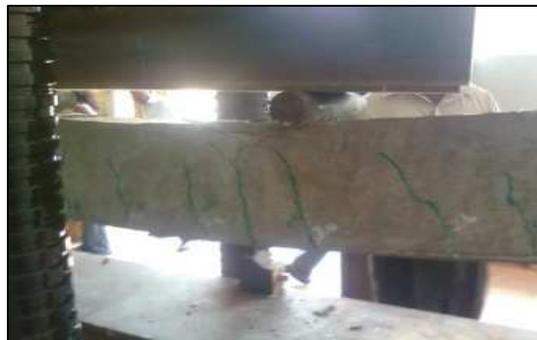
Figure 5 shows the flexural cracks were propagated on the control specimen and Figure 6 shows the failure mode of the FRP bonded specimens and finally it can be concluded that the all the beams have failed due to flexure.

Figure 5: Flexural cracks of the control specimen

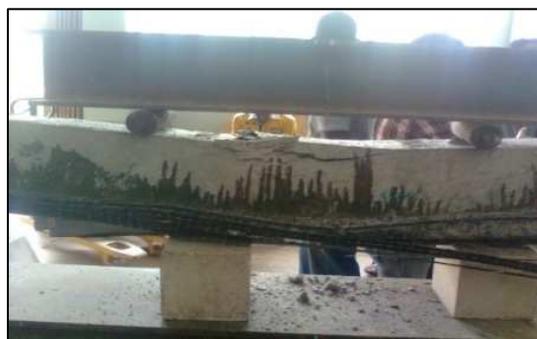
Figure 6: Concrete crushing and de-bonding of FRP bonded beam

It is thus evident that FRP contributes to the beam's flexural capacity by restricting the opening of vertical cracks in the constant bending region. When the load and deformation are further increased, the developed interfacial shear stress at the concrete-FRP interface exceeds its capacity and then separation of the FRP plate could occur.

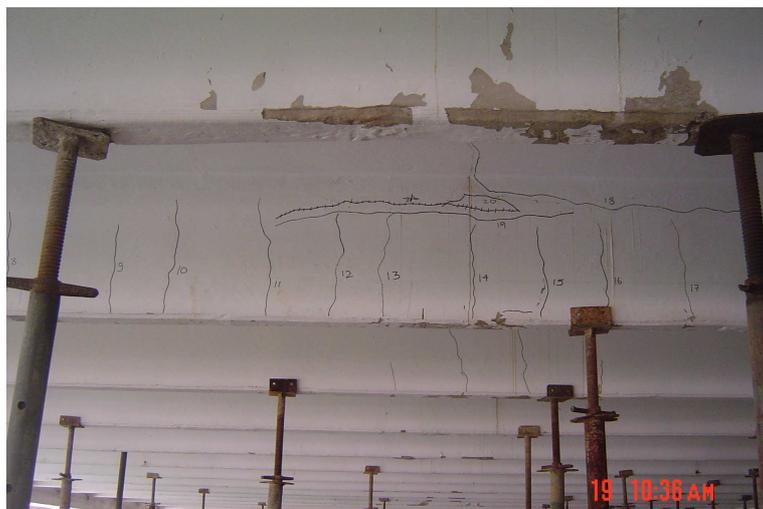
During the blast that occurred, the building was hit by the many pieces of a small plane. The blast occurred just before the plane hit the building and hence could have occurred right above the roof slab. Some pieces and the engine of the plane ended up within the building. The location of blast was about 20 m above the roof terrace floor. This blast occurred at about 9.00 pm and a subsequent fire spread within the building. During the period of fire fighting and later, furniture, equipments and debris due to fire have been thrown away from the upper floors of the building on to this roof terrace. The day following the incident, it was observed that roof terrace floor was stacked with debris with over 2.0 m height. The debris consisted of equipments, computers, furniture, etc. which would have exerted significant loads. It was also reported that no such cracks have been observed in floor beams (floor beams in other location are also pre-stressed concrete T-beams) in other locations. Figures 9 and 10 show the details of cracked T-beams. The cracks appeared near the mid span of the beams are hair line cracks with maximum cracks width was about 0.1 mm.

Figure 9: Hair line cracks on T-beams close to mid spans

It should be noted that the crack width are as small as 0.1 mm with only few isolated ones reaching 0.2 mm. This is an indication that the steel wires would have suffered some overstress and would have been stressed beyond the 0.2% proof stress, thus inducing some permanent elongation. However, there is one property of steel that can still allow such over-stressed steel to be used further in structures for supporting loads of normal magnitudes. That is if a steel section does not break due to over stressing that induce work hardening, the steel can still be used if it is unstressed to a appreciably lower stress.

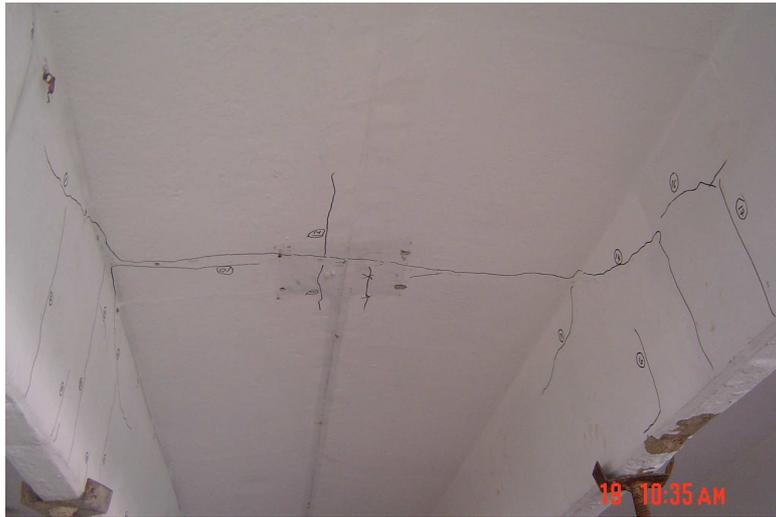
Figure 10: Cracks at T-beams flanges

The beams have suffered two types of loading that could be of significant nature. The blast that occurred over the 4<sup>th</sup> floor roof slab as could be seen with images captured by cameras with night vision would have applied a very significant impact load in the downward direction. The other load was due to throwing of various goods during fire fighting and cleaning operations that followed afterward by the security forces. It should be noted that for a heavy slab supported on beams, a gradual built up of debris could primarily over-load the slab and such overloading is most likely to cause few flexural cracks at the centre. However, there could also be few localized damages.

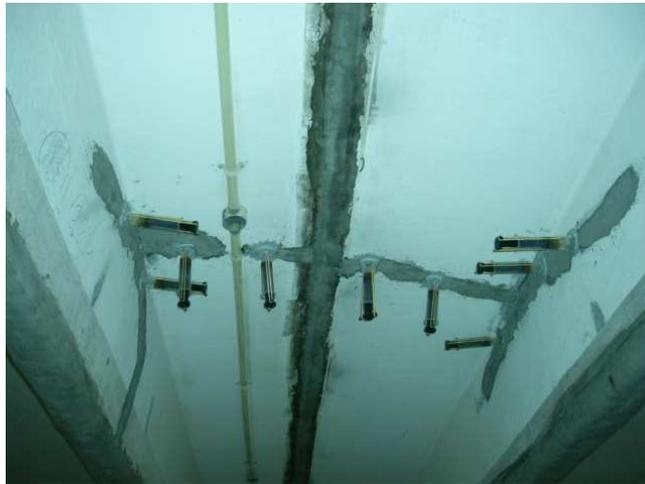
It can be stated that the stresses in concrete are within the allowable limits for this 10.6 m long beam. The allowable value for compressive stress will be  $0.33 \times f_{cu} = 0.33 \times 40 = 13.2 \text{ N/mm}^2$ . The allowable tensile stress for a class 2 structure is about 2.0 N/mm<sup>2</sup>. Figures 11 and 12 show the repair work of cracks in beams and floor and the beams completed with FRP work.

Figure 11: Repairs to non-structural cracks

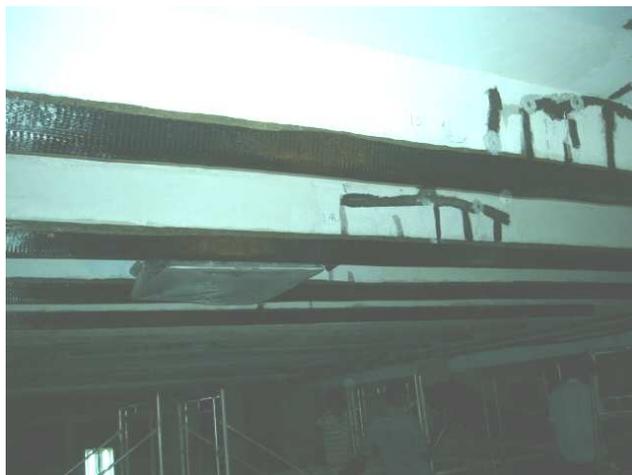
Figure 12: The beams completed with FRP work

It was recommended to strengthening all the beams with cracks to enhance the flexural capacity using carbon fiber reinforcements so that some extra load could be independently carried by the carbon fiber based system. This position can be supported by the following facts. The systems of beams are pre-tensioned. Thus, the energy stored in the system allowed the beams to survive the blast though they could have suffered excessive deflections that led to high strain in steel wires and also some cracks at the very highly reinforced flanges. However, system recovered after the blast and indicated the possibility carrying self weight without noticeable deflections. A load test carried out has also indicated the possibility of carrying some loads without noticeable deflections. Here, bonded system was considered as a secondary system that would give a guarantee on load carrying capacity, both short and long term. Hence, only the additional loads that could induce further deflections were considered for determining the FRP system. The loading considered were the followings: (a). Allowance of  $1.0 \text{ kN/m}^2$  is desirable to take account of finishes. (b). Live load on the slab can be considered as  $5.0 \text{ kN/m}^2$  The corresponding design bending moments will be about 27 kNm for permanent loads (with a partial factor of safety for loading of 1.4) and 154 kNm for live loads (with a partial factor of safety for loading of 1.6) under simply supported conditions.

The corresponding resisting tensile force due to above loading is 322 kN. Hence required area of carbon fiber reinforcements is 386 mm<sup>2</sup> (corresponding to design tensile strength of carbon fiber and epoxy composite is 834 N/mm<sup>2</sup>).
