STRUCTURAL ASSESSMENT OF REINFORCED CONCRETE BRIDGE STRUCTURES EXPOSED TO CHLORIDE ENVIRONMENT

ABSTRACT: This research paper presents a new approach to develop a simple bridge rating system for Sri Lanka. This approach evaluates the current performance of concrete bridges on the basis of simple visual inspection and non-destructive tests. The main reason to conduct this research is to develop a proper bridge management system for Sri Lanka and to develop deterioration prediction curve for bridges. Also some applicable maintenance techniques are introduced according to identify condition state of the bridge based on the durability performance of the each bridge. During field inspection, the major issue to deteriorate concrete bridges was identified as chloride induced corrosion called chloride attack. To understand flexural capacity reduction and area reduction of reinforcing steel due to corrosion, Accelerated Corrosion Testing Method (ACTM) was carried out at the laboratory. By conducting load tests, the flexural capacity reduction of deteriorated concrete beam was compared with control beam. More than fifty percentage of area reduction in steel bars was observed while it reduced

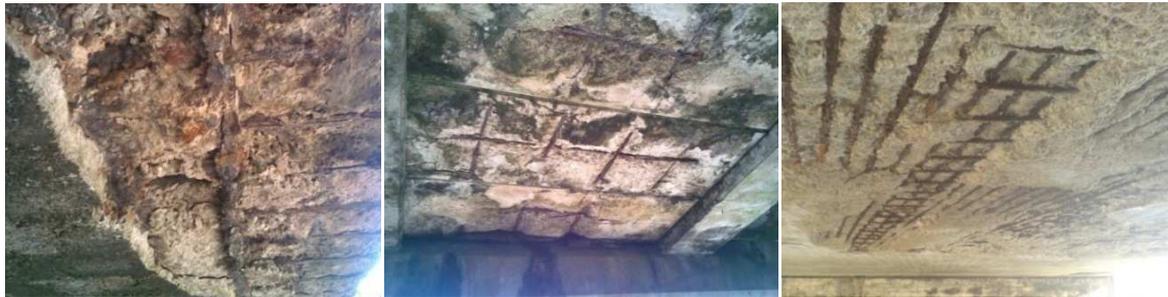
Figure 1: Damages in Bridges due to Corrosion

(a) Hikkaduwa town bridge

(b) Ginthota bridge

(c) Koggala bridge

Two types of non destructive tests were used during field inspections. Rebound hammer test was carried out by pressing rebound tip on the concrete surface. When tip compressed on concrete surface, it rebounded and gives rebound number. After referring to the standard graph, the related compressive strength of concrete can be used to determine the strength of the structural element. In pulse velocity test, at the beginning the transducer and receiver was kept at a spacing of 0.3 m and the travel time of the pulse was measured. Then pulse velocity was found by known distance and time. Then referring to standard graphs which show the relationship between compressive strength of concrete and the pulse velocity, the actual strength of the bridge element can be found. Also to increase the accuracy of results, these testing were carried out with the spacing of 0.6 m and 0.9 m. The pulse velocity test can be done by direct or indirect method. But values obtain by direct method are more reliable than indirect method. However, due to access limitations indirect method was applied to the most of the bridges. In addition, pulse velocity test was carried out to identify structural defects such as cracks, voids, etc in the bridge elements. During the inspection, it was identified that bridges along the coastal belt have deteriorated more than the bridges located inland. It is mainly due to corrosion of reinforcements caused that is by chloride induced corrosion cracking called chloride attack along the bridge girders. (see Figure 1)

According to field inspection results, it is revealed that Hikkaduwa Bridge (BRN 5) located very close to main city shows remarkable strength reduction compared to other bridges in the coastal belt. Visual inspection details at Koggala Bridge (BRN 11) revealed that it has large amount of corroded reinforcement but it did not show considerable strength reduction as Hikkaduwa Bridge (see Figure 4). The main reason for that may be the aging of these structures. Also all the bridges located along the coastal belt show average compressive strength of concrete about 40 N/mm² while bridges in country region shows average compressive strength of concrete about 30 N/mm². Further it was noticed that most of bridges along the coastal belt have been in having a service life of less than 25 years.

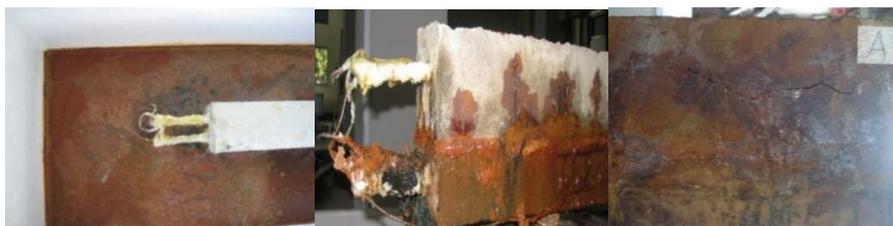
Figure 3: Corrosion Test Process

(a) Cast beams

(b) NaCl bath

(c) Power supply unit

(d) During ACT process

(e) After 15 days

(f) Cracks after 35 days

Two reinforced concrete beams were cast in the laboratory using ordinary portland cement with maximum aggregate size of 20 mm. The cross section of the beam is 100 x 150 mm and the length of the beam is 2000 mm. The characteristic design compressive strength of concrete used is 20 N/mm². To avoid corrosion of reinforcing steel, the extended length of bars was coated with grease and wax. To simulate the deterioration of beams in short time period, accelerated corrosion testing method (ACTM) was adopted. The specimen is immersed in a sodium chloride (NaCl) solution bath with Cl⁻ concentration of 5% and that acts as electrolyte. In this method, reinforcing steel of the specimen that have to be corroded, is made as anode and copper bars in the bottom of acrylic tank is used as cathode (see Figure 2). The current supply was connected to one end of steel bar in the specimen and the other end is connected to the copper bars. The constant and continuous current supply of 0.7 Amp was applied to all the specimens until corrosion crack generated. Figure 3 shows the sequence of steps followed during the ACTM in the laboratory.
