# Investigation of damage on wall panels due to blast vibration

Department of Civil and Environmental Engineering

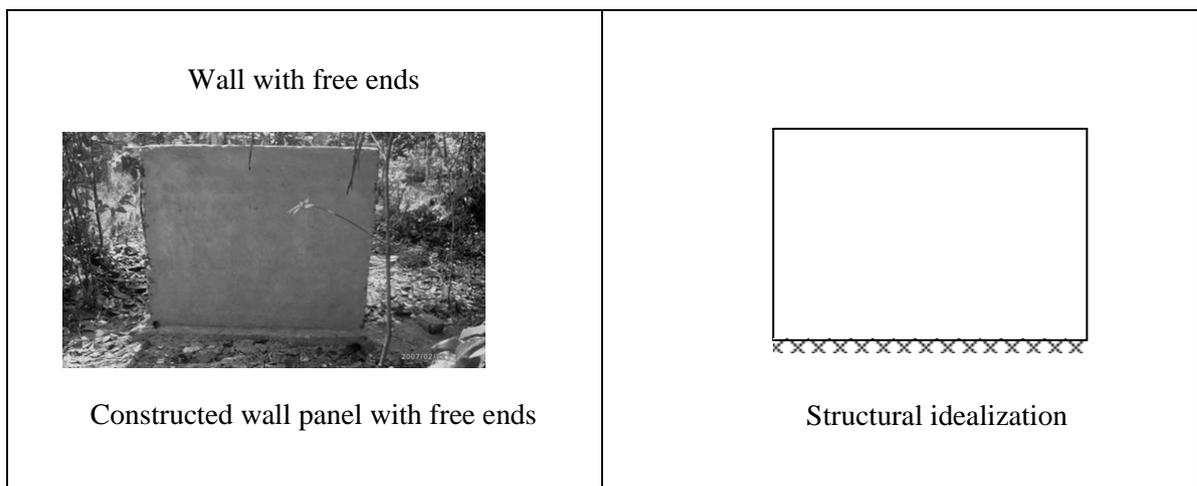
**Figure 5: Idealization of the wall panel for FEM**

The experimental model structure was idealized (Figure 5) and modelled in FEM using SAP 2000 software [6]. This model was used for both the static and dynamic analysis of the structure.

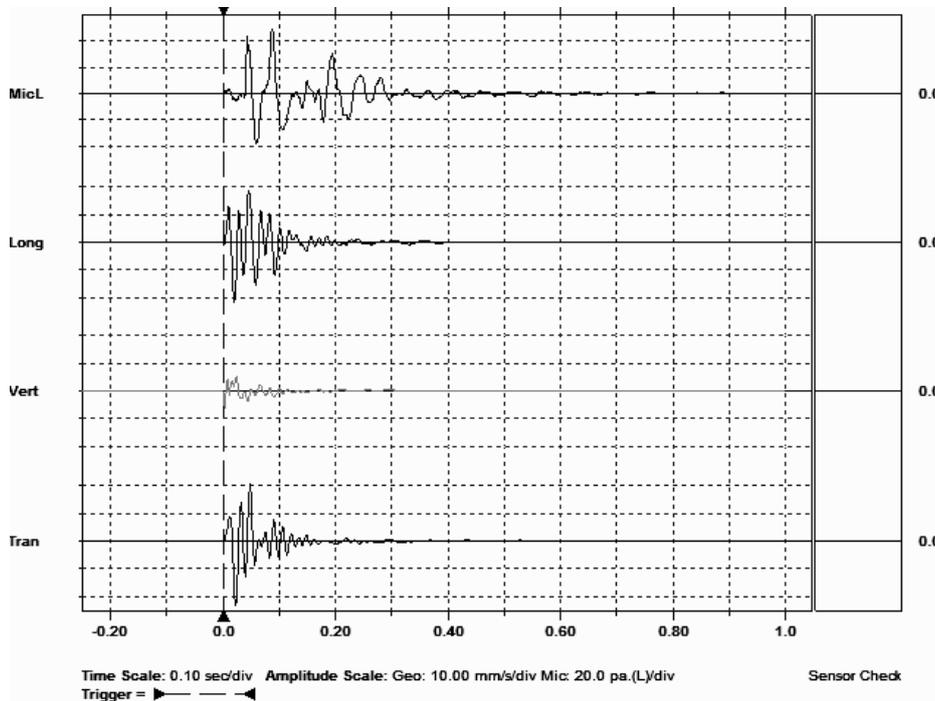
Figure 6: Vibration in three directions and noise level measured using the seismograph

The event report of a particular blasting event was obtained using the Blastware software. Among the three vibrations and noise level, vibration in longitudinal direction was selected as it was always dominant in affecting the structure (Figure 6).

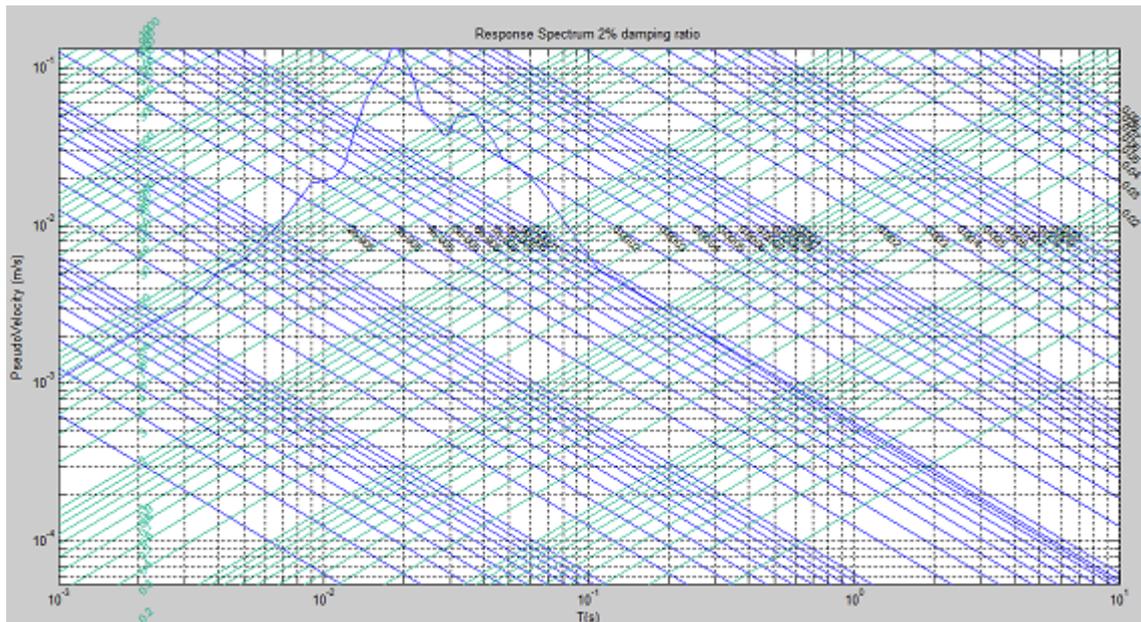
Figure 8: Response spectrum for longitudinal vibration of 30.2 mm/s ppv blasting event

The response spectrum obtained for the longitudinal vibration of the event of 30.2 mm/s ppv is shown in Figure 8.

According to the experimental study, the cantilever type wall panel experienced a structural separation from the foundation by a significant cracking at a ppv of 30.2 mm/s at 50 Hz of frequency. This vibration magnitude is similar to the magnitude reported in a previous study in which safety of low-rise residential structures from vibrations generated by mining blasting was investigated [4]. In their study, surface cracks were observed whereas in the current study, a significant crack at the bottom of the structure was observed. This different might be attributed to the low stiffness of the structure used in the current study: for a structure with low stiffness large effect due to the blasting activity can be expected. Another previous study has identified structural cracks even below 2mm/s ppv (frequency range of 10-50 Hz) in which the vibration considered was a continuous vibration over a long period of time and the wall panels were having openings [10]. As the effect of such a vibration last long period, it is comparable with the current study where a sudden large vibration over a short period of time was investigated.
