5.1 TEA FACTORY- RISK ASSESMENT

The objective behind this assessment which involved of evaluation of the present condition of tea factory in terms of fire safety concerns.

Tea Estate and the Factory are situated in Rathnapura. Located an altitude of 1000 feet, it has a plantation area of 110.88 Hectares. The Factory is a three storied structure, with the ground floor resting on sandstone base and brick and stone retention wall acting as the supporting column (base) for the garage and trough section of the first floor.

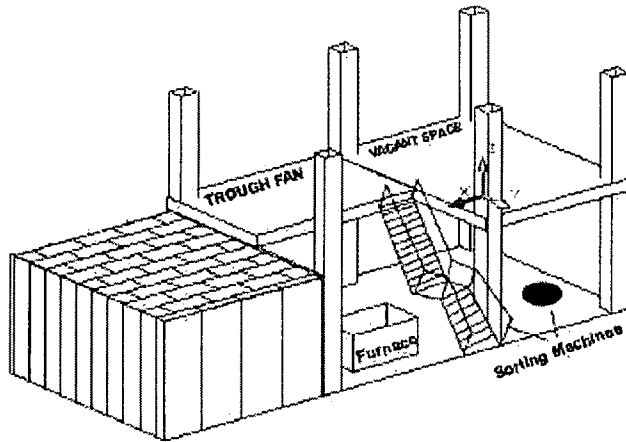
Ground and First Floor Elevated Profile

The First Floor covers the largest area in the factory and is entirely made up of wooden planks and beams.

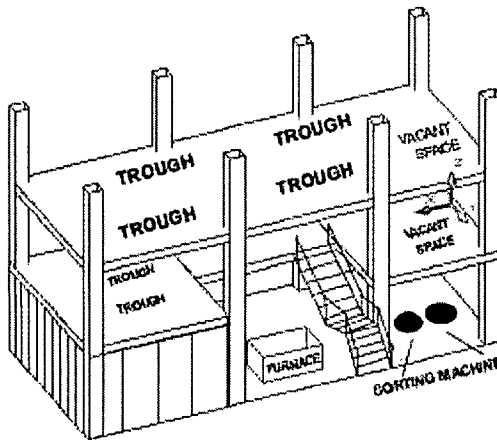
Ground, First and Second Floor Elevated Profile

- a) Date of Erection : Not Known(Before 1990s)
- b) Number of Floors : Ground Floor & two lofts
- c) Verandahs : Along Both sides
- d) Porticos : Two storied porch rising through front Verandah

- e) Annex : Fire wood shed at the rolling room end
- f) Foundations & Ground
- | | | |

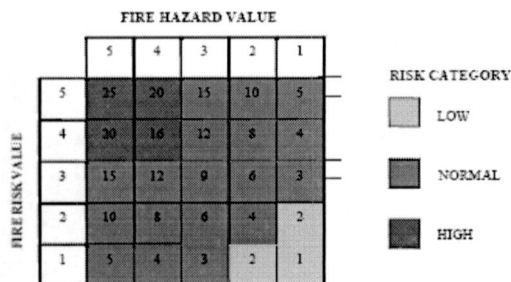
Figure 5.1: Risk value matrix

Fire Hazard consequences	Value	Fire Risk
Negligible	1	Unlikely
Slight	2	Possible
Moderate	3	Quite Possible
Severe	4	Likely
Very Severe	5	Very Likely

Risk Value Matrix

Fire Risk Number = 6
