PERFORMANCE OF UNREINFORCED MASONRY BUILDINGS AGAINST NATURAL DISASTERS – REVIEW STUDY

Abstract

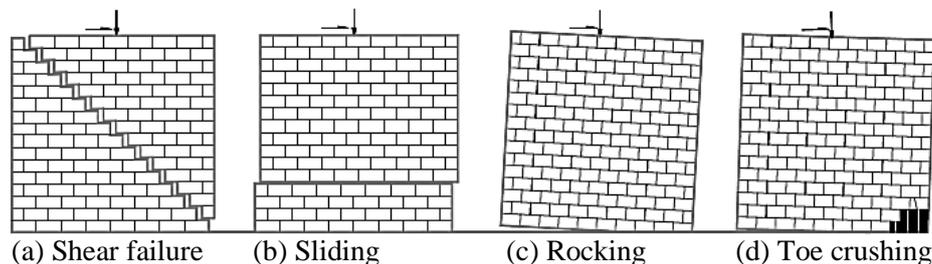
During earthquakes, the ground shakes in all directions and generates inertia forces that the construction material should be able to withstand. According to Saatcioglu et al. (2005), under seismic loading, URM walls have two possible failure mechanisms: in-plane and out-of-plane. In-plane failures are characterized by a diagonal tensile crack pattern while out-of-plane failures are characterized by cracks that are primarily along the mortar bed joints. The principle in-plane failure mechanisms of URM walls subjected to earthquake actions are shear failure, sliding failure, rocking failure and toe crushing (Figure 1).

Figure 1: In-plane failure modes of a laterally loaded URM wall (ElGawady et al., 2006b)

Since the tensile strength is very low, significant cracking starts (with the initiation of an earthquake) in the regions subjected to tension. Vertical cracking starts at the lateral corners of the walls, where the tensile stresses are higher due to out-of-plane bending produced by seismic forces perpendicular to the walls (Figures 2 and 3). The continuity of ground movement produces large vertical corner cracks tend to separate the walls from one another (Figures 2 and 3). Shear forces generated by lateral seismic forces acting within the plane of the walls, produce diagonal cracks, which usually follow stepped patterns along the mortar joints (Figures 1 and 3).

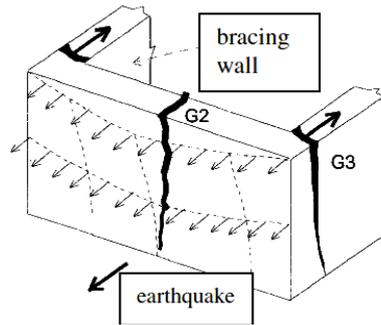
The typical out-of-plane failure patterns of URM wall resulted from an earthquake are shown in Figure 2.

Figure 2: Typical crack patterns of URM buildings due to out-of-plane failure (Bartolome et al., 2004)

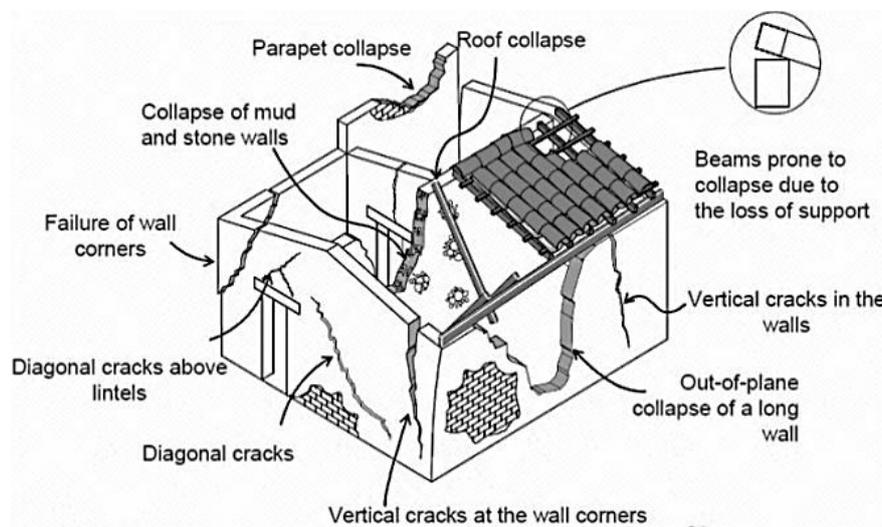
The performance of small adobe and low-quality mud-brick constructions varied from no damage to collapse and, within any specific area, the performance of these buildings depended on a number of parameters, including wall thickness, roof mass, size of rooms, and quality of materials (Webster, 2008). Earthen structures have less ductility and are very brittle resulting in sudden failures under seismic loading without any warning. The traditional earthen buildings are vulnerable due to a perverse combination of the mechanical properties of their walls where earthen walls are dense and heavy, have extremely low tensile strength resulted from weak material, lack of reinforcement, poor workmanship and null maintenance (Bartolome et al., 2008 and Blondet et al., 2008). Common failure modes of adobe structures were reported by Blondet (2003) (Figure 3). The same failure modes can be expected for other types of masonry buildings.

Figure 3: Seismic deficiencies of adobe masonry (Blondet, 2003)

Due to the stress concentration at the corners of openings (i.e., doors and windows), diagonal cracks often start at these locations (Figure 3). Front walls are usually the first to collapse in an earthquake and overturning onto the adjacent street (Blondet et al., 2008). According to available literature (Bartolome et al., 2004, Bartolome et al., 2008, Blondet et al., 2008, D’Ayala, 2011 and Kaplan et al., 2008), seismic failures illustrated by Figure 3, are also common in other URM structures as well as adobe houses. Examples for these types of failures of URM buildings are illustrated by photos in Figure 4.

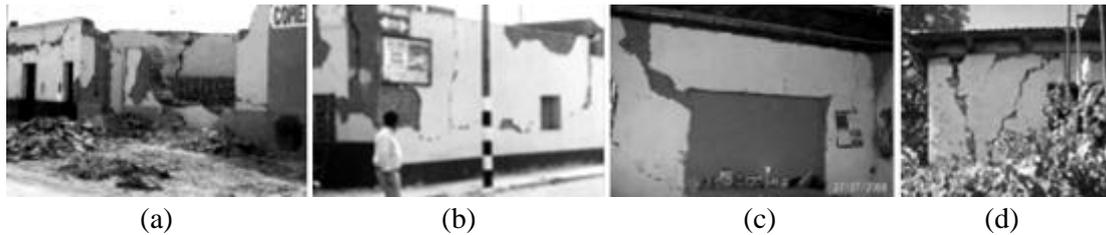
Figure 4: Seismic cracks in URM houses: (a) Collapse due to out-of-plane failure (severe earthquakes in Peru) (Bartolome et al., 2004), (b) Typical cracks on adobe houses due to out-of-plane seismic forces (Bartolome et al., 2004), (c) Shear cracks initiated at the corners of openings in wall of house in La Tinguina (in-plane failure) (Bartolome et al., 2008), (d) Wall-diagonal crack and vertical corner crack (both in-plane and out-of-plane failure) (Kaplan et al., 2008)

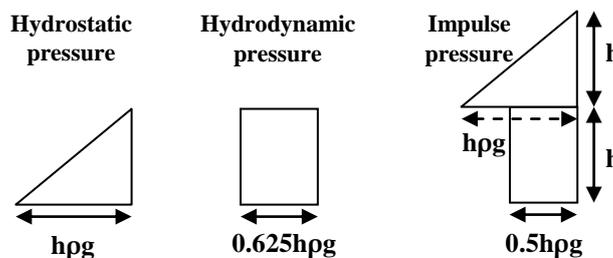
Damages of URM buildings by tsunami effects could be occurred due to hydrostatic, hydrodynamic, impulsive, impact and buoyancy forces (Figure 5) (Renuka and Lewangamage, 2011). Authors have conducted an investigation using a single storied and two storied house modeled in a Finite Element Modeling (FEM) program based on common sizes of houses in Sri Lankan coastal line and inundation depth of 1.5 m and 2 m of Sumatra Tsunami, 2004. Results showed that, main failure types in URM structures had caused by bending, diagonal tension and compression, overturning and sliding (Figure 6).

Figure 5: Components of tsunami induced forces (Renuka and Lewangamage, 2011)

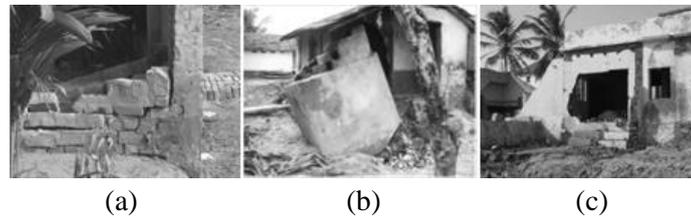
The URMs performed very poorly in resisting the lateral forces of the tsunami. Bending capacity of unreinforced brick masonry was very low against the hydrostatic forces of the tsunami (Maheshwari et al., 2005 and Renuka and Lewangamage, 2011). Overturning moment increases with higher pressure while resisting moment reduces due to small lever arm. Higher building weight and gravel type soil around base will reduce the overturning effect.

Figure 6: Damage to URM buildings by December 26, 2004 Sumatra Earthquake; (a) Brick masonry walls in Talenguda-sliding failure (Maheshwari et al., 2005), (b) Brick masonry in Trincomalee- overturning due to foundation scouring (Khazai et al., 2006), (c) Buildings in Meelamanakudy- bending failure (Maheshwari et al., 2005)

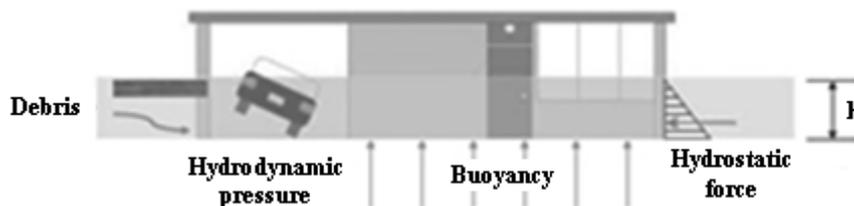
Damages of URM structures by a flooding resulted from storm surge, riverine flooding, or urban flooding are mainly occurred due to physical forces such as hydrostatic loads, hydrodynamic loads, impact loads and buoyancy (Figure 7) (Caraballo-Nadal et al., 2006 and Rogers, 2012).

Figure 7: Typical forces generated by flooding (Caraballo-Nadal et al., 2006)

Hydrostatic forces occur when slow rising flood water comes into contact with a building or its components. Lateral hydrostatic forces are generally not sufficient to cause deflection or displacement of a building unless there is a significant difference in water elevation on opposite sides of the wall in contact with the flood water. However, if there is the significant difference, permanent deflections and damage to structural elements within the building may be occurred. Hydrodynamic forces are lateral loads induced by flowing flood water around the buildings. These forces are a function of flood water velocity and the building geometry and have capability to collapse structural walls or floor systems. The buoyant forces are the vertical uplift of the structure due to the displacement of water. When the buoyant forces associated with the flood exceed the weight of the building components and the connections to the foundation system, the structure may float from its foundation. Impact loads are the direct forces associated with waves, as typically encountered during coastal flooding, or the impact of floating debris

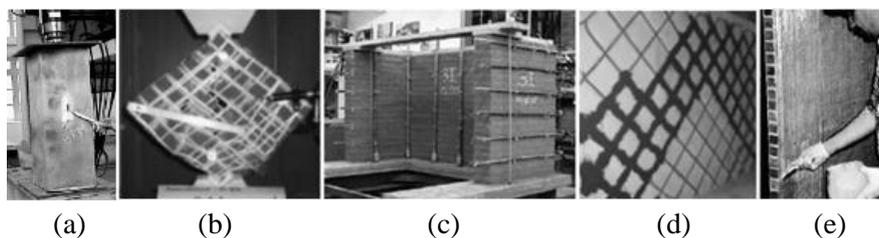
The purpose of introducing a retrofitting method is to prevent the sudden collapse of buildings during natural disasters to allow people to evacuate (Bartolome et al., 2004). Further, according to Arya (2000), it can be said that, retrofitting is refer to upgrade the disaster resistance of an existing unsafe building, or a damaged building while repairing. Accordingly retrofitted building becomes safer for future disaster occurrences. Though it may not be designed to be totally disaster-resistant but to avoid its collapse, adequate reinforcements should be provided. Retrofitting of masonry buildings against earthquakes, tsunami and flooding are discussed in this section. Several seismic retrofitting techniques for URM buildings are shown in Figure 8.

Figure 8: Retrofitting techniques; (a) Ferrocement (Shah, 2011), (b) PP-band mesh reinforcement in testing stage (Sathiparan et al., 2008), (c) External horizontal bamboo (outside), external vertical bamboo (inside), internal horizontal chicken wire mesh and ring beam (Dowling et al., 2005), (d) Old tire strips (Kaplan et al., 2008), (e) Application of FRP reinforcement (Velazquez-Dimas, 2000)

Shah (2011), has conducted an experiment on evaluating the effect of ferrocement (Figure 8-(a)) using twenty one masonry columns of 221 mm x 221 mm x 784 mm and they were tested under axial compression. Author proved that, ferrocement cover of 6.125 mm and 1:2 cement sand mortar with water cement ratio of 0.5 ($w/c=0.5$) and mesh spacing of 12.25 mm on masonry columns substantially improved the load carrying capacity, ductility and serviceability of unreinforced masonry columns. Author found that, encasement of unreinforced masonry brick columns by ferrocement double the failure load, increased ultimate load by 121%. When lower the wire spacing in mesh, lower the average crack spacing. However, mortar strength has comparatively smaller influence on failure load. Clear cover to reinforcement shall not be greater than 2 mm and one layer of reinforcement may be satisfactory for each 6 mm thickness of ferrocement casing. Premature failure may occur if mesh is not properly wrapped and plaster does not fully penetrate into it. Ferrocement can be used to repair column, which have been loaded close to failure. It seems that this method is simple, cost effective, required low technology and adding limited mass to the existing structure.

Sathiparan et al. (2008), tested four 1/4 scale wallets (with dimensions of 50 mm thickness, 275 mm width and 275 mm height): two wallets for diagonal shear test (Figure 8-(b)) and two wallets for out-of-plane test. Authors found that, using PP-band mesh reinforcement for strengthen the URM wall can be increased both in-plane shear and out-of-plane resistance of the wall. Further authors found that, residual strength after crack initiation and residual stiffness of masonry wall with PP-band mesh retrofitting are directly proportional to PP-band density up to some value and after the optimum value, they do not increase with the PP-band density; and looseness of the PP-band attachment with specimen reduces the residual strength after crack initiation of the specimen. However, an application of surface finishing makes beneficial effect in residual strength as it fills the gap between mesh and wall.

Dowling et al. (2005), suggested that a significant improvement in the earthquake resistance of adobe mud-brick structures can be obtained by using external vertical and horizontal bamboo reinforcement, internal horizontal chicken wire mesh reinforcement and a ring beam (Figure 8-(c)). They tested five 1:2 scale u-shaped adobe mud-brick walls; each had 150 mm thick, 1800 mm wide and 1200 mm high wall. One of them was a control specimen with no retrofitting and others were retrofitted as one with only corner pilasters; one specimen with internal horizontal chicken wire mesh, external vertical bamboo (inside and outside) and timber ring beam; one specimen with internal vertical bamboo reinforcement, internal horizontal chicken wire mesh and a timber ring beam; and another specimen with external vertical (inside) and horizontal (outside) bamboo reinforcement, internal horizontal chicken wire mesh and a timber ring beam. Authors have named each specimen for better identification. Above mentioned specification of five wallets are summarized in Table 1. A downward restraining force of 125 kPa was applied to the tops of the 'wing' walls (acting as in-plane shear walls) of all specimens by tension bars between timber plates and beam resting on the walls, and the concrete base.

Kaplan et al. (2008), has performed an experiment with axial load, lateral load and incremental reversed cyclic imposed sway to the models to obtain hysteretic behaviour, to identify the effect of old tire strips as reinforcement on strengthen of URM buildings against earthquakes. They used six full scale masonry wall constructed by standard masonry bricks with vertical holes; three walls are having window opening and other three are with no openings. One from each two types was used as control specimens. Groves were formed by removing plaster on other four walls according to the pattern of tire strips to be placed. One of two walls with no openings was retrofitted diagonally by tire strips and other one was retrofitted by both vertically and horizontally placed tire strips. Two walls with openings were retrofitted by diagonally placed tire strips; and additional vertical and horizontal tire strips for one of them and only horizontal tire strips for other, were placed around the wall openings to prevent local crushing around the wall openings. After placing tire strips, groves were covered by plastering or high quality mortar, (Figure 8-(d)). In addition to the experiment, models were also analyzed by using commercially available software, ANSYS. Authors found same results from numerical and experimental investigations. Tire strips have no significant effect on lateral load capacity of walls, whereas use of the strips improves ductility and energy consumption capacity of the walls significantly with improvement in displacement capacity about 250~300% in the case of no openings and about 30~40% in the case of the walls with openings. Introduction of strips do also have some minor effect on the damage pattern. Kaplan et al. (2008), identified that, the
